**Table 1-2 Evaluation and Assessment Summary**

Alaska Railroad Corporation hired PND Engineers, Inc. to provide the condition assessment services on the Whittier Marine Terminal. PND's Michael Beglin provided an initial site visit on September 29<sup>th</sup>, 2020 to review the project site and meet with ARRC's Elizabeth Greer.

The inspection was conducted as a Routine Inspection as outlined in the *ASCE Manuals and Reports on Engineering Practice No. 130 (MOP 130)*, **Waterfront Facilities Inspection and Assessment**. The purpose of the inspection was to assess the general condition of the structures, assign a condition assessment rating to each structure, assign element-level damage ratings to each structural component, provide maintenance recommendations, and advise client on maintenance priorities.

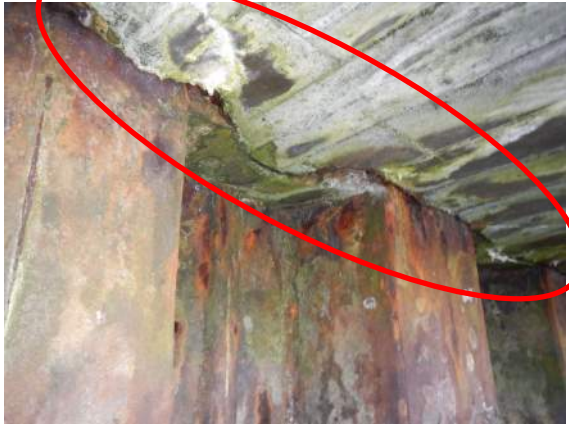
| A photograph showing the concrete sheet pile cap with a large red oval highlighting areas of spalling and cracking. | <p>Photograph No. MW-3</p> <p><u>Description:</u></p> <p>Concrete spalling and cracking was observed in places along the concrete sheet pile cap. Rebar is exposed in several locations and cracks exceed 1/4" near the east end, as well as, along the sheet pile to cap interface.</p> |

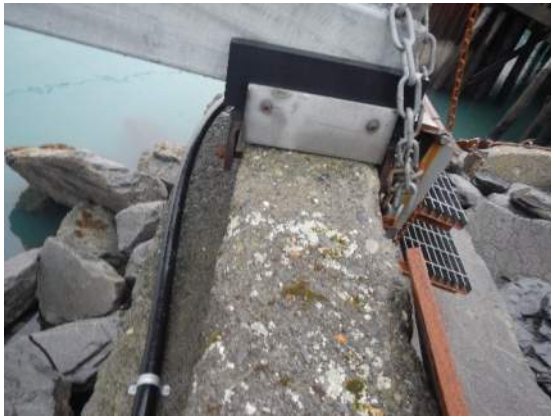
Photograph No. MW-5

The damaged concrete cap and sheet pile at the east end of the wharf, compromises the support provided to the catwalk for dolphin #4 access.

- PND recommends the following action items: Immediately restrict heavy loads from the NE corner, where the wall is leaning.
- Within the next 1-3 years, install a new catwalk support (turning dolphin #4). Restrict use of the catwalk until a competent support is installed.
- At an appropriate low tide, inspect the face of the wall for localized failures in the sheet pile and patch as necessary. Fill sinkholes due to scour and patch holes as they form, until full replacement can be accomplished.
- Repair damaged appurtenances as soon as practical.
- Due to the widespread section loss and deficiencies observed, a full replacement of the Marginal Wharf sheet pile wall should take place within the next 3-6 years. In order to do this, the design and permit process should begin within the next 1-3 years.
- Continue routine inspection of the structure, at a minimum of every 2 years.

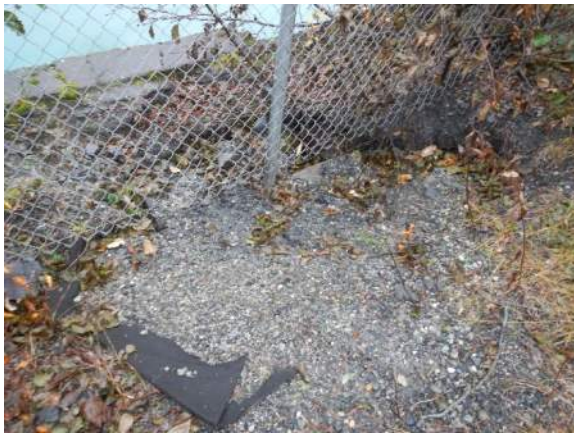
Photograph No. MW-6

Observed sinkholes adjacent to a tower and near the east end of the wharf. Currently temporarily repaired with geotextile and gravel fill.

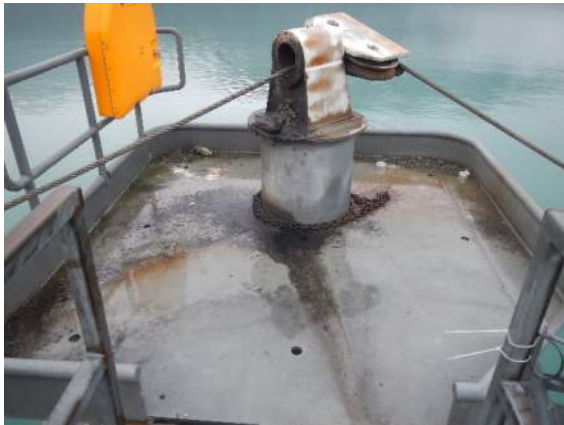
Photograph No. D4-2

Minor coating damage and corrosion observed.

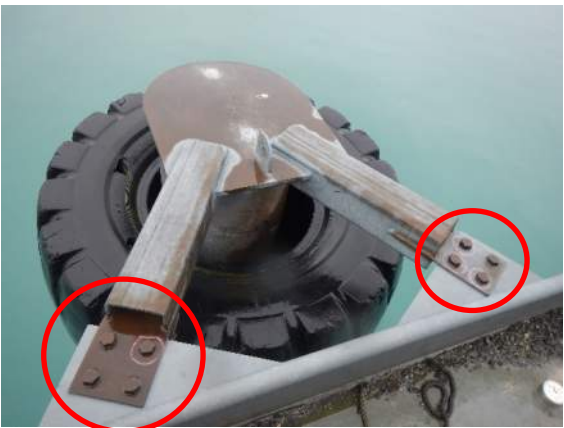
Photograph No. D4-3

Minor deterioration to tire fenders, such as, cuts, gouges, tears, etc. (4) loose bolts observed on the fender bracket.

- Tighten loose fender bracket bolts by the turn-of-nut method within 1-3 years.
- See Marginal Wharf regarding the catwalk support deficiencies and recommended restrictions.
- Continue routine inspection of this structure, at a minimum of every 4 years.

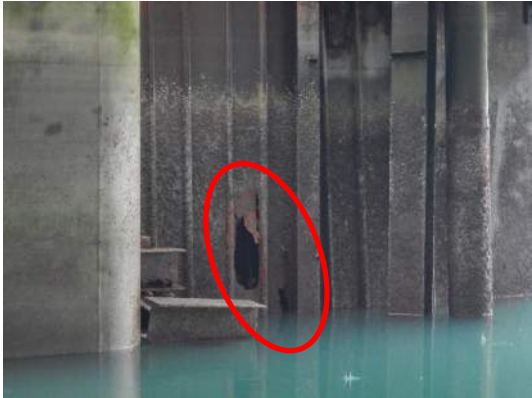
| | <p>Photograph No. TR-1</p> <p><u>Description:</u></p> <p>(2) perforations observed on the cell's south side.</p> |

- Repair all Closed Cell #1 and #2 sheet pile holes with cover plates, core through concrete pad and fill void with concrete or grout within 1-3 years.
- Patch/repair spalled concrete on concrete pad extensions where rebar is exposed to slow deterioration within 1-3 years.
- Concrete pad extensions no longer carry heavy loads as they were initially designed; however, if temporary or permanent loads should increase beyond foot traffic, further analyses and repairs should be performed.
- Replace all damaged or missing timber trestle members within 1-3 years.
- Continue routine inspection of this structure, at a minimum of every 2 years.

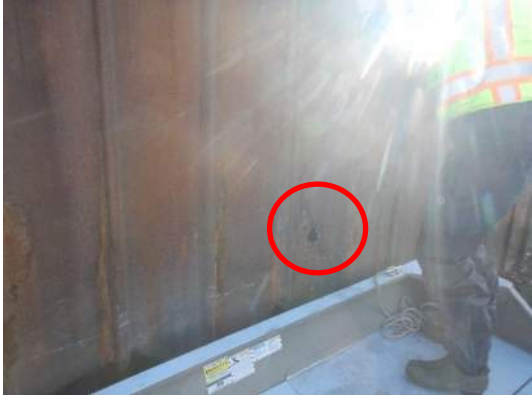
| | <p>Photograph No. TR-2</p> <p><u>Description:</u></p> <p>Perforation observed on the cell's north side.</p> |

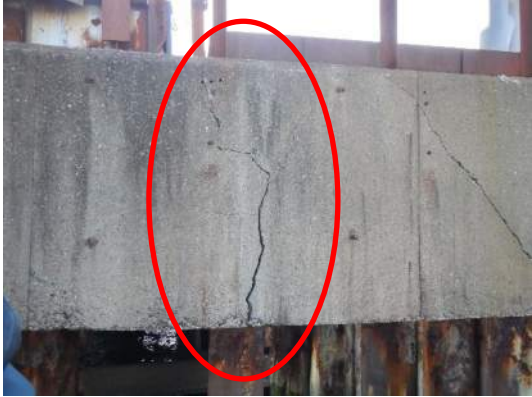
| | <p>Photograph No. TR-3</p> <p><u>Description:</u></p> <p>(2) concrete "fingers" extend from the closed cell and are supported by H-piles. The SE finger has (2) full depth cracks, one of which is ~1/2" wide.</p> |

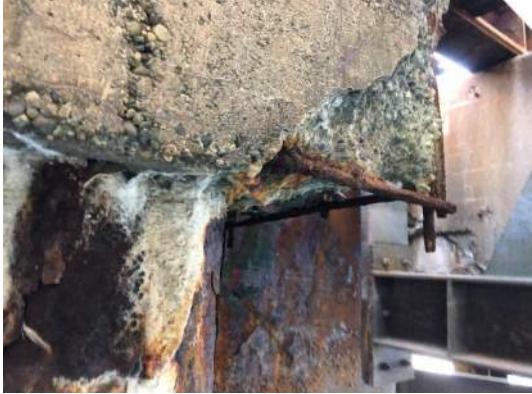
| | <p>Photograph No. TR-4</p> <p><u>Description:</u></p> <p>(2) concrete "fingers" extend from the closed cell and are supported by H-piles. The SW finger has complete loss of concrete cover over rebar at (1) bottom corner.</p> |

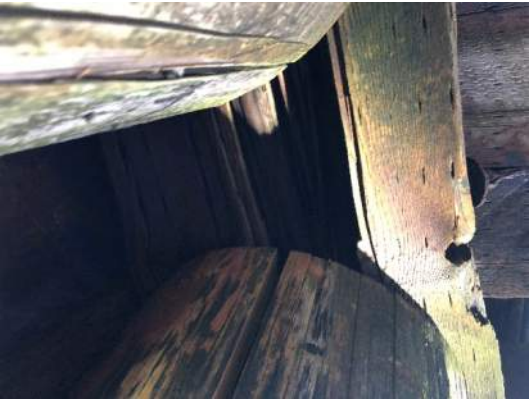
| | <p>Photograph No. TR-9</p> <p><u>Description:</u></p> <p>Split and damaged abutment pile cap timber. Looking up.</p> |

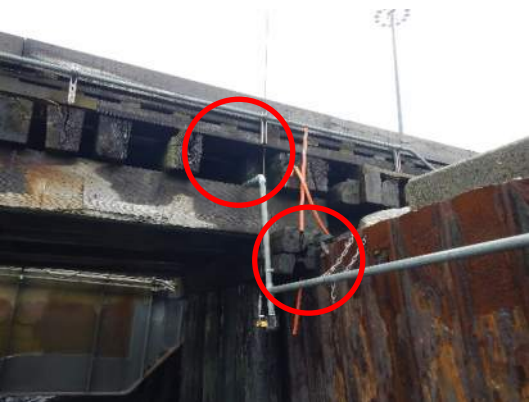
| | <p>Photograph No. TR-10</p> <p><u>Description:</u></p> <p>Missing transverse deck timber and crushed/split cap beam near the abutment.</p> |

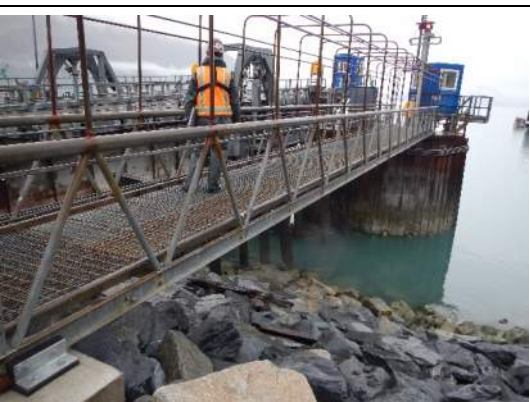
| | <p>Photograph No. TR-11</p> <p><u>Description:</u></p> <p>Less than 50% of the surface is affected by corrosion.</p> |

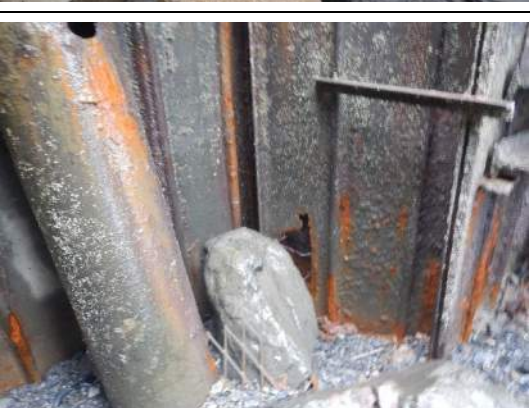
| | <p>Photograph No. TR-12</p> <p><u>Description:</u></p> <p>Several perforations were observed along the abutment sheet pile wall. Connections, bracing, and general load paths are not clear due to modifications of the existing structure throughout it's life</p> |

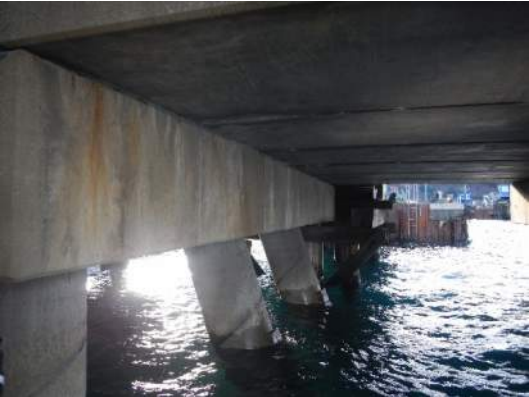
| | <p><b>Photograph No. PP-1</b></p> <p><u>Description:</u></p> <p>Less than 50% of the surface is affected by corrosion. No visual evidence of section loss observed. Platform #1 and #2.</p> |

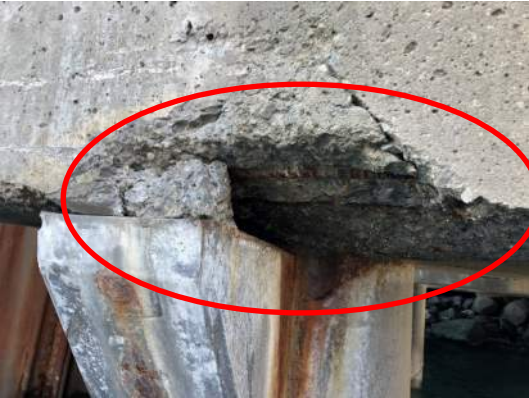
| | <p><b>Photograph No. PP-2</b></p> <p><u>Description:</u></p> <p>Spalling at bottom corners and edges near the face &amp; fender, have eliminated concrete cover, exposing rebar. Platform #1 and #2.</p> |

- Repair the damaged fender connections (cracked welds and broken threaded rods) and patch the spalled concrete (where rebar is exposed) within 1-3 years.
- Repair the sink hole with placement of riprap around the bottom of the undermined backwall, followed by placement of geotextile and fill within the approach. Repair as soon as practical.
- Repair the steel tube rail if functionality is affected.
- Continue routine inspection of this structure, at a minimum of every 4 years.

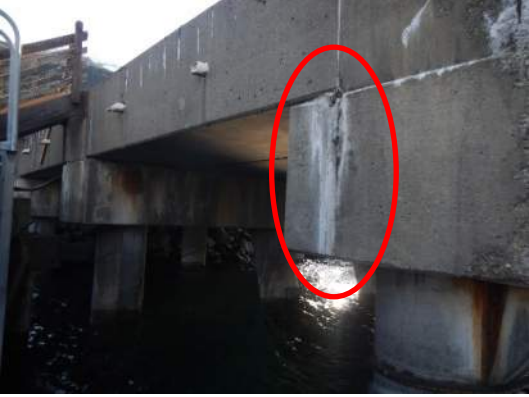
| | <p><b>Photograph No. PP-3</b></p> <p><u>Description:</u></p> <p>On the east end of the most seaward pile cap, a crack extends below the deck panel. Platform #2.</p> |

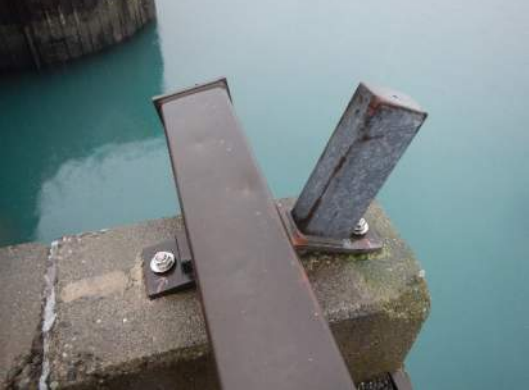
| | <p><b>Photograph No. PP-4</b></p> <p><u>Description:</u></p> <p>A steels square tube rail along the end of the dock is bent from impact with damaged connections to the dock. Platform #1 and #2.</p> |

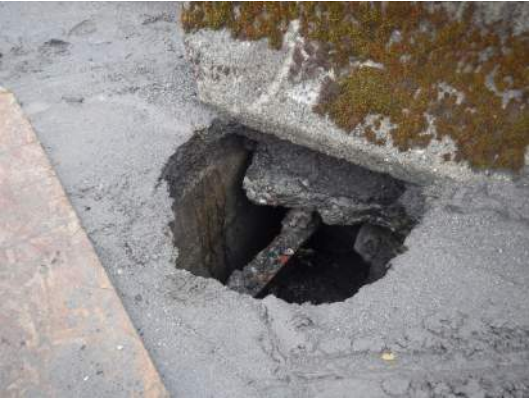
| A close-up photograph of a large, irregular hole in a concrete abutment. The hole is deep and dark, with some debris visible inside. The surrounding concrete is weathered and has some green moss or algae growing on it. | <p><b>Photograph No. PP-6</b></p> <p><b>Description:</b></p> <p>A sink hole was observed at the east end of the abutment.</p> |

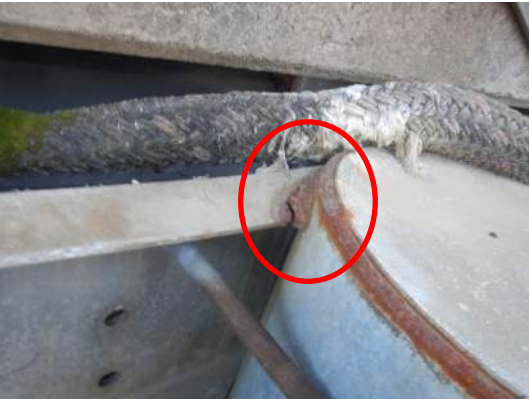
| A close-up photograph of a metal fender assembly. A red circle highlights a crack in the weld joint between two metal components. The metal is dark and appears to be part of a larger structure. | <p><b>Photograph No. PP-7</b></p> <p><b><u>Description:</u></b></p> <p>Cracks observed in fender assembly welds. Platform #1 and #2.</p> |

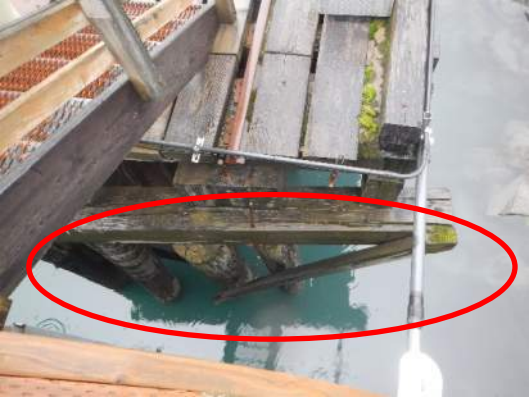
| | <p>Photograph No. TT-5</p> <p><u>Description:</u></p> <p>Many diagonal timbers, i.e. lateral bracing, are split, broken, missing or otherwise damaged.</p> |

- Replace all diagonal timber bracing in-kind within 1-3 years.
- Shim piles that do not bear on the timber pile cap with steel within 1-3 years.
- Piles that exceed 20% section loss or have splits that extend into or beyond the middle of the pile should be replaced or repaired within 1-3 years.

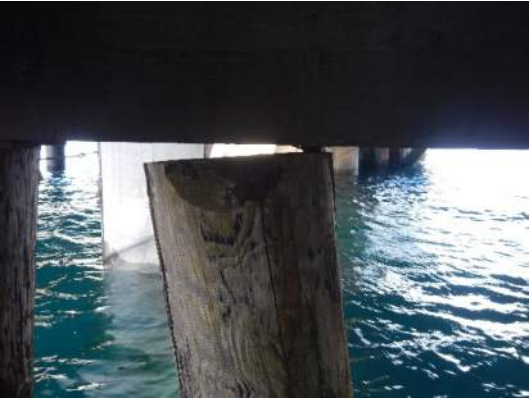
| | <p>Photograph No. TT-6</p> <p><u>Description:</u></p> <p>Pile not bearing on the pile cap on a bent located just west of Pass-Pass platform #1.</p> |

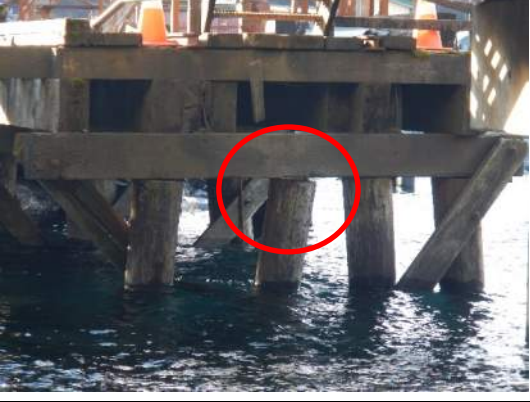
| | <p>Photograph No. TT-6</p> <p><u>Description:</u></p> <p>Pile not bearing on the pile cap at the east side of the most westerly trestle section.</p> |

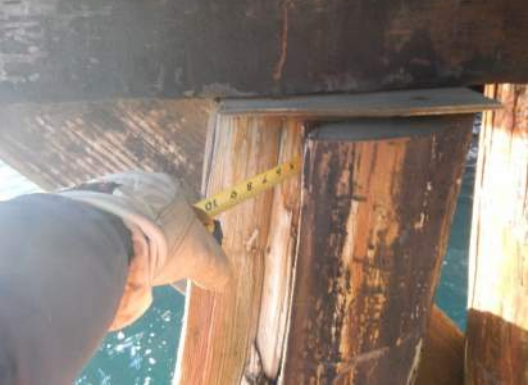
| | <p>Photograph No. TT-7</p> <p><u>Description:</u></p> <p>Several piles are split, cracked, and in some cases section loss exceeds 50%.</p> |

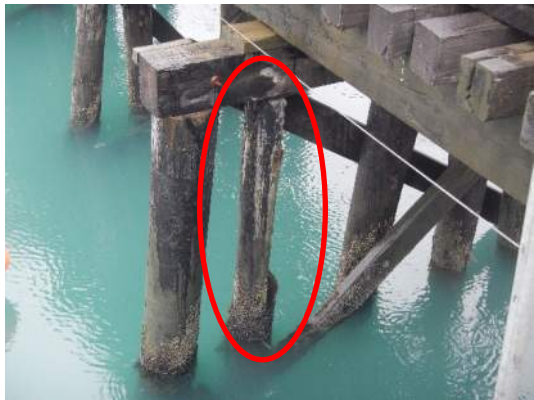
| | <p>Photograph No. TT-8</p> <p><u>Description:</u></p> <p>Timber pile with severe section loss.</p> |

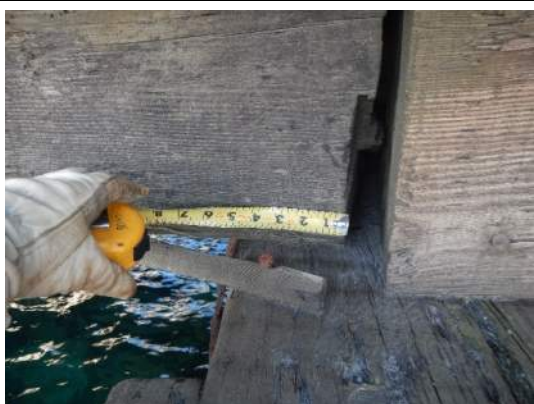
| | <p>Photograph No. TT-9</p> <p><u>Description:</u></p> <p>Many, if not all, timber stringers have inadequate support length and do not meet current codes. i.e. the length of girders contacting the pile caps is too short.</p> |

- Retrofit all pile caps so that the stringer support length meets current code requirements within 1-3 years.
- Replace in-kind the damaged stringer (longitudinal girder) and all damaged ties (transverse deck members) within 1-3 years.

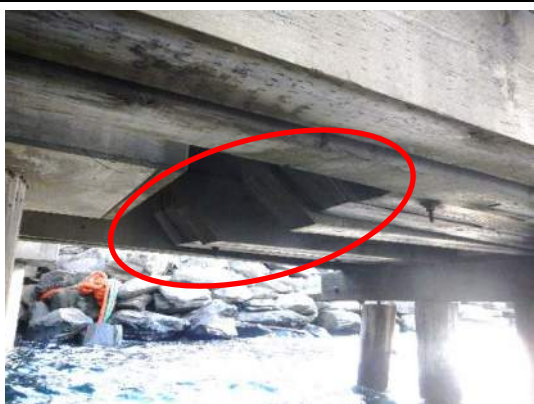
| | <p>Photograph No. TT-10</p> <p><u>Description:</u></p> <p>Modified interior stringers for pass pass platform supports. Note, exterior stringers remain simply supported per original design.</p> |

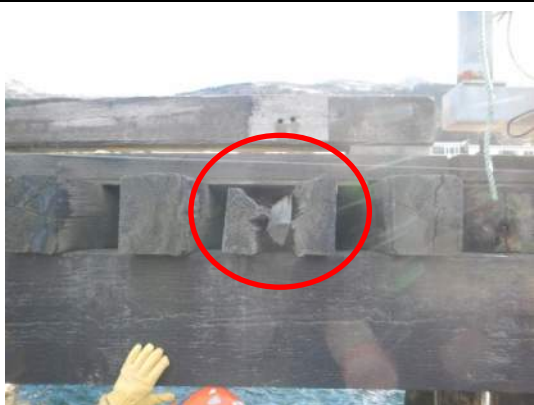
| | <p>Photograph No. TT-11</p> <p><u>Description:</u></p> <p>Several split and damaged timber transverse deck members were observed east of winch cell #1, primarily the northern end of the members.</p> |

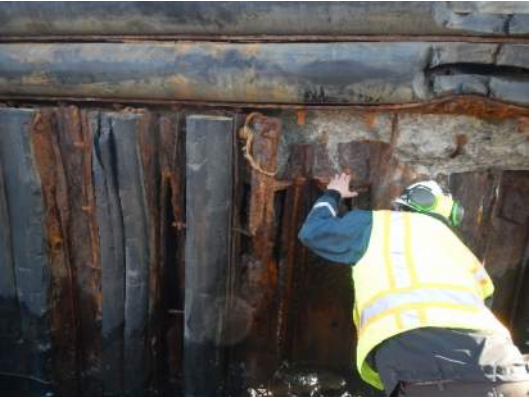
| | <p>Photograph No. WC-1</p> <p><u>Description:</u></p> <p>Holes were observed all (3) winch cells. Numerous “large” holes, splits and cracks were observed in winch cells #1 and #2. (3) holes were observed on the north side of winch cell #3; however, the north face was obstructed with a tire fender.</p> |

- Repair all Winch Cell #1, #2, and #3 sheet pile holes with cover plates. At the face of the cells, where the most significant damage occurred, an engineered repair is recommended to repair the sheets and fenders within 1-3 years.
- Core through the concrete deck and fill cell voids with concrete or grout within 1-3 years.
- Patch/repair spalled concrete on concrete caps where rebar is exposed within 1-3 years.
- Continue routine inspection of this structure annually due to the severity of deterioration and frequency of use.

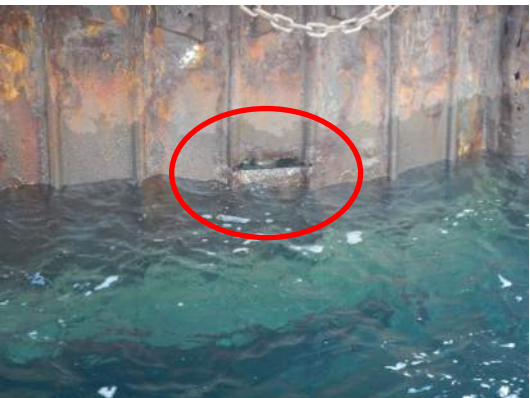
| | <p>Photograph No. WC-2</p> <p><u>Description:</u></p> <p>Typical hole observed in winch cell.</p> |

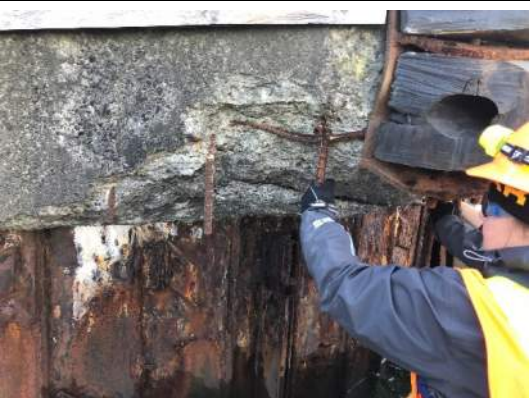
| | <p>Photograph No. WC-4</p> <p><u>Description:</u></p> <p>Concrete spalling and cracking was observed at the bottom corners at each cell face. Rebar is exposed in several locations.</p> |

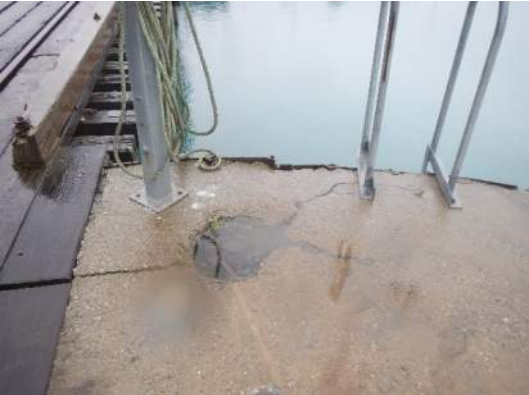
| | <p>Photograph No. WC-6</p> <p><u>Description:</u></p> <p>The top surface of the concrete caps has moderate cracking, staining and spalling.</p> |

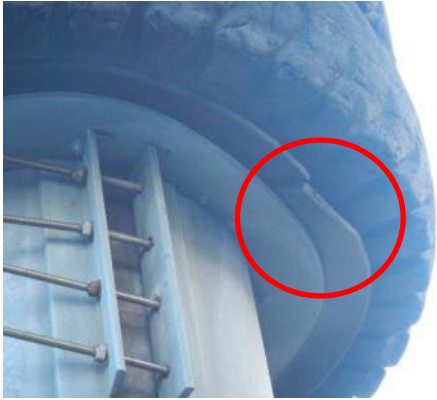
| | <p>Photograph No. D1-1</p> <p><u>Description:</u></p> <p>Bents plates observed on king pile brackets. No impact to functionality and structural stability.</p> |

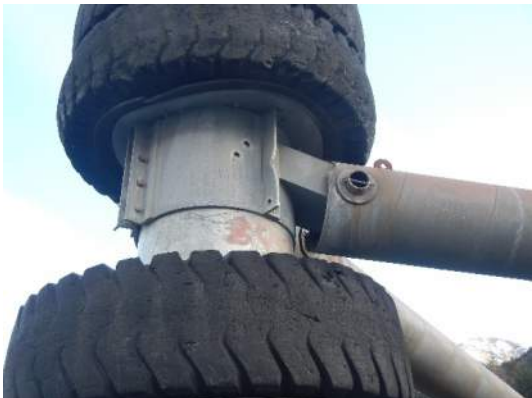
| | <p>Photograph No. D1-1</p> <p><u>Description:</u></p> <p>Minor wear and gouges on the rubber tires.</p> |

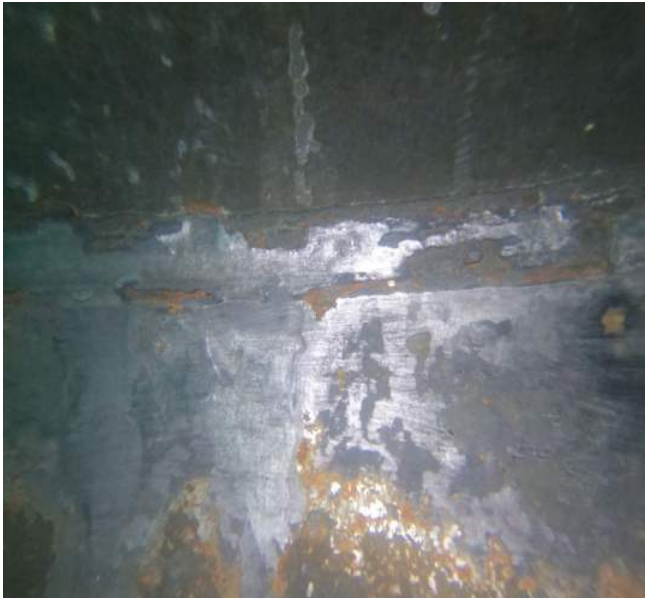
Image 1: Heavy Corrosion

- Inspect/monitor the heavy corrosion near the circumferential welds during next routine inspection.
- Monitor the bulbous deformation on the vertical pile during next routine inspection.
- Continue routine inspection of this structure, at a minimum of every 4 years.

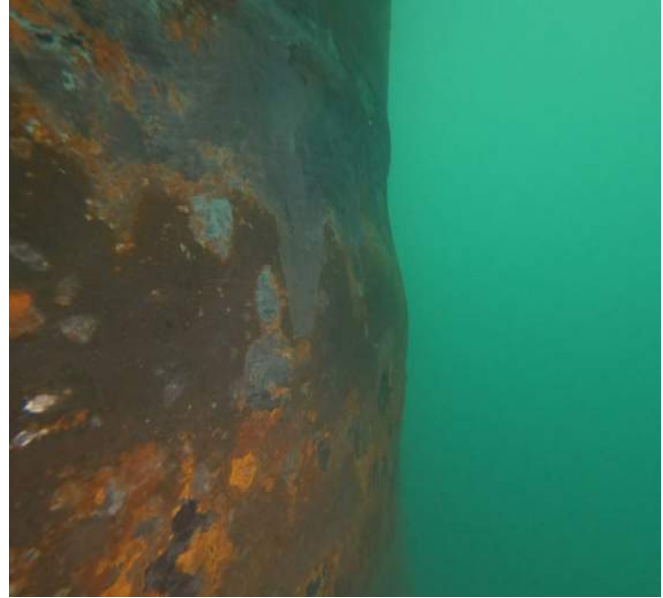
Image 2: Bulbous Deformation

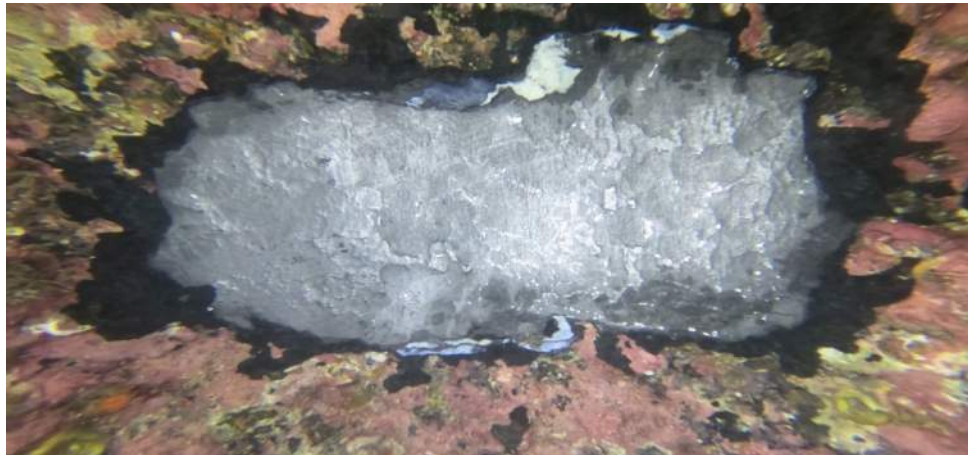
Image 1 Heavy Corrosion on Cell #1

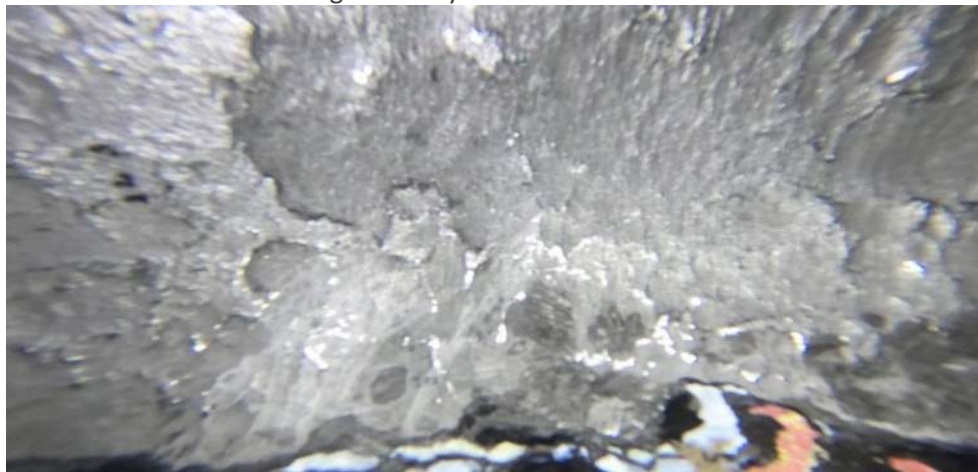
Image 2 close up of corrosion

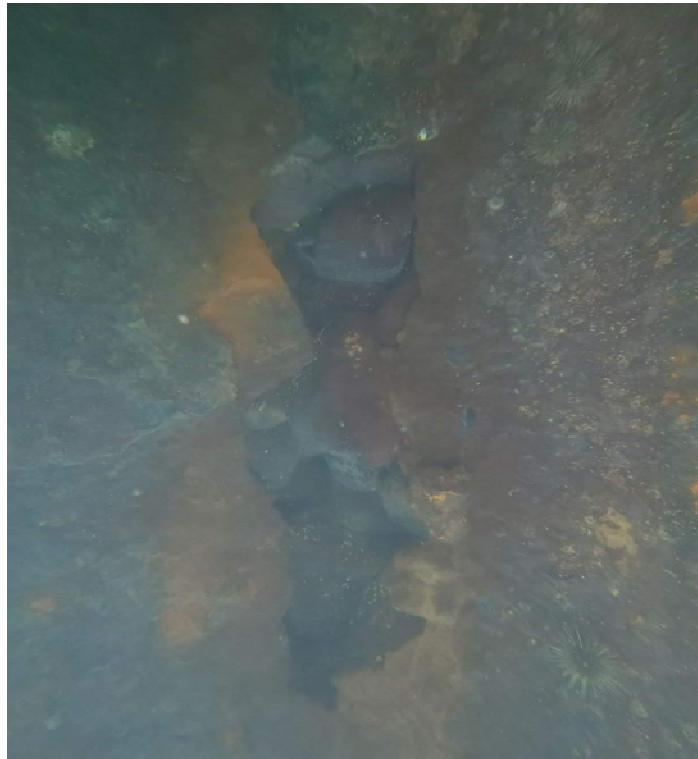
Image 3 - 4" x 18" Hole North Side of Cell

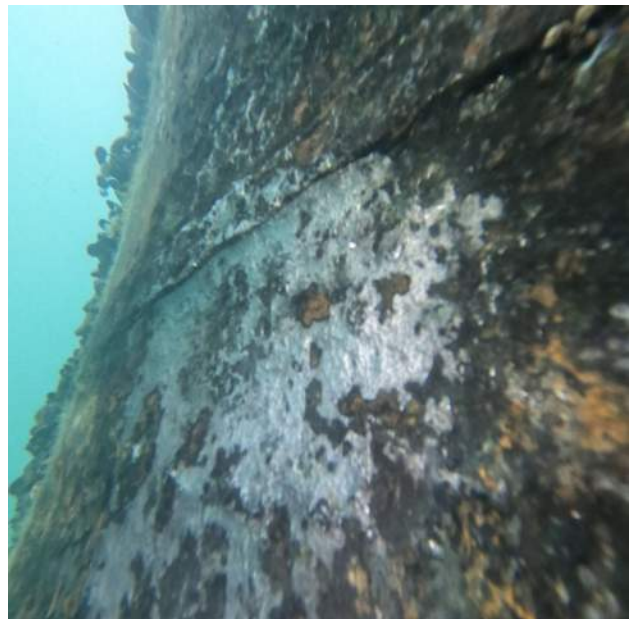
Image 7 – Knife Edge Corrosion Pile Weld

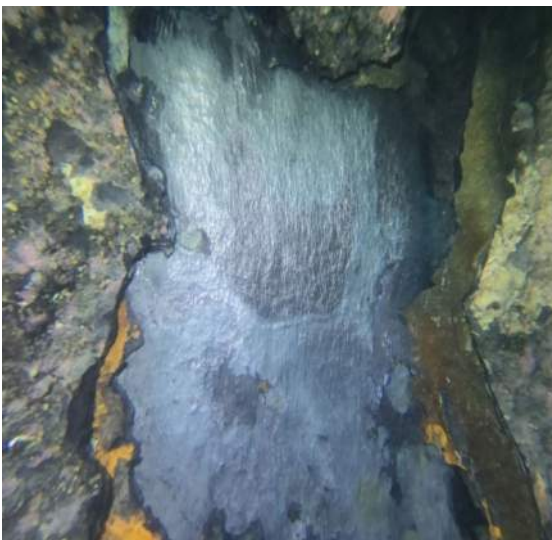
Image 8 – Heavy Corrosion

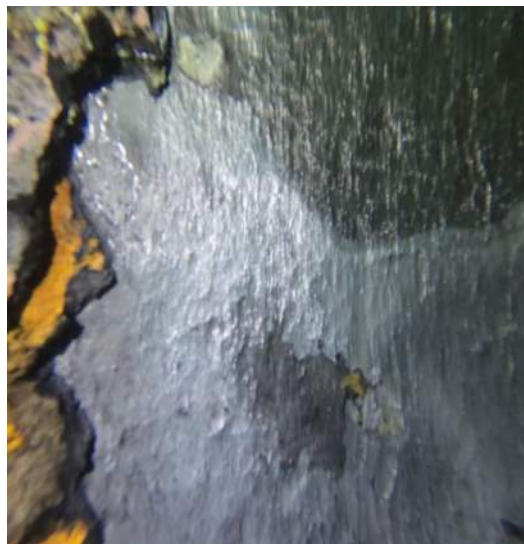
Image 9 – Close up of corrosion

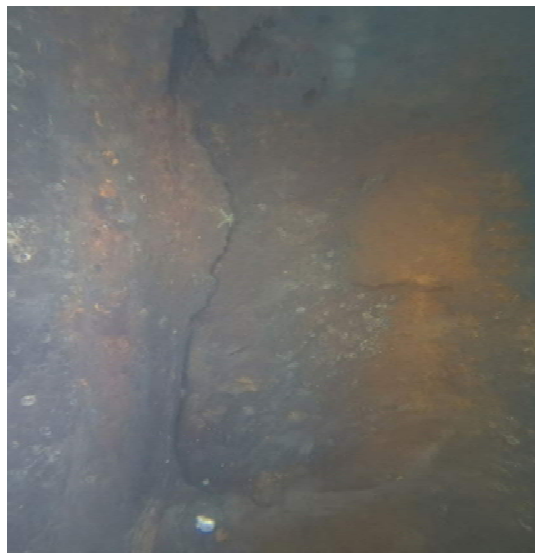
Image 10 – 12" x 3 ½" Hole Cell north side

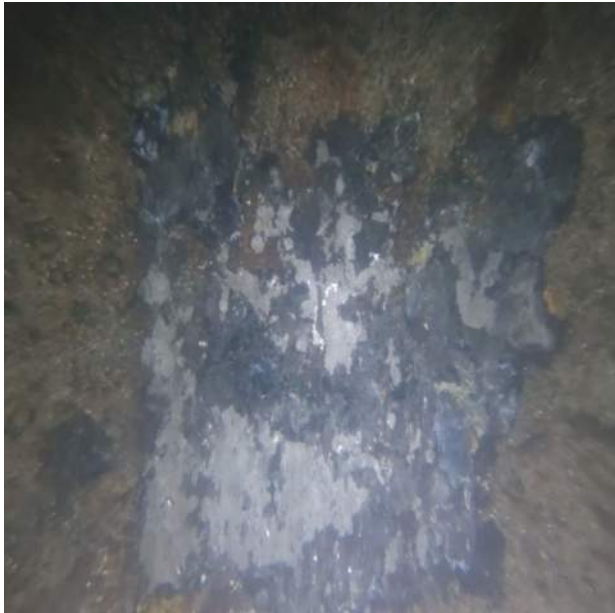
Image 11 – Typical corrosion found

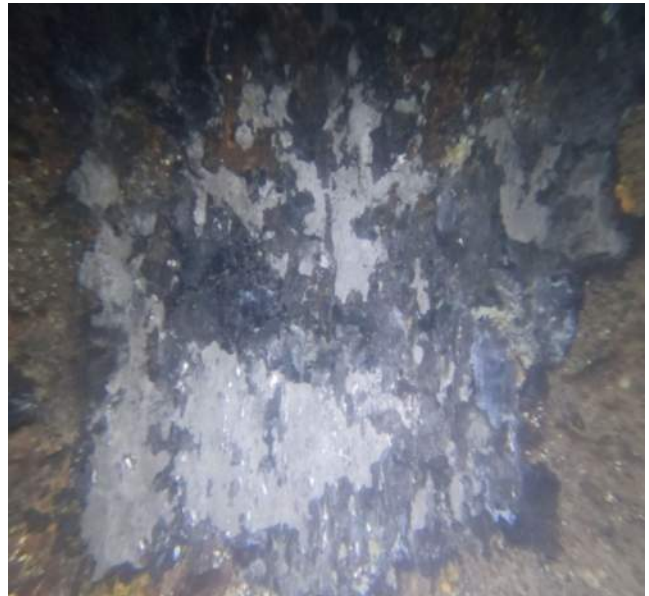
Image 12 – Close up of corrosion

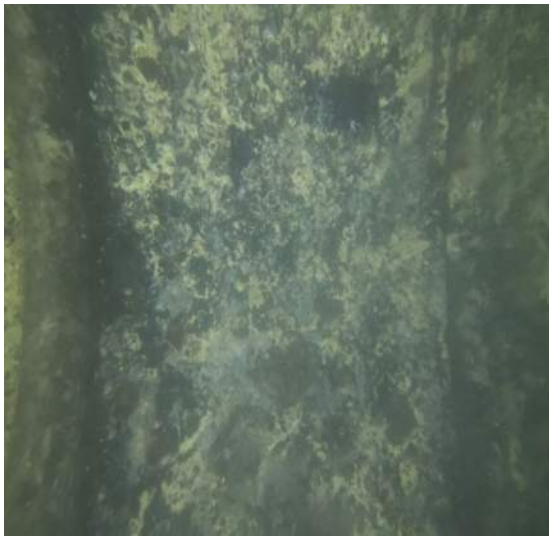
Image 13 – Typical Medium Corrosion

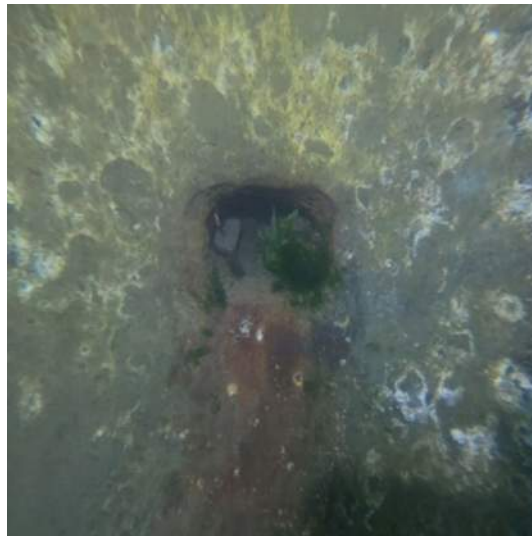
Image 14 – 3" Hole found (Corroded Tieback?)

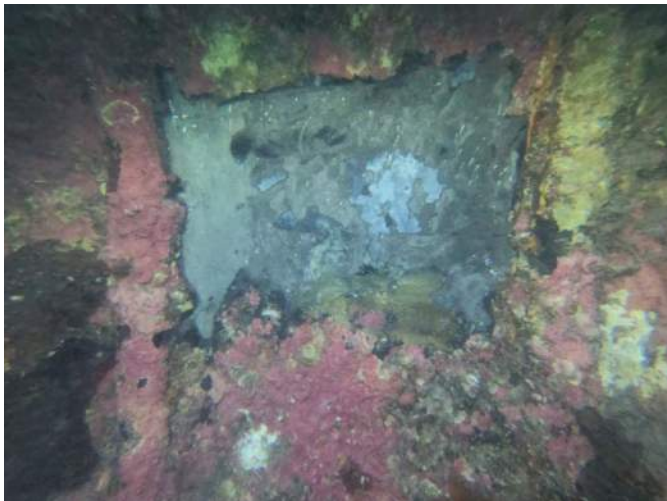
Image 16- Heavy corrosion, pitting and material loss

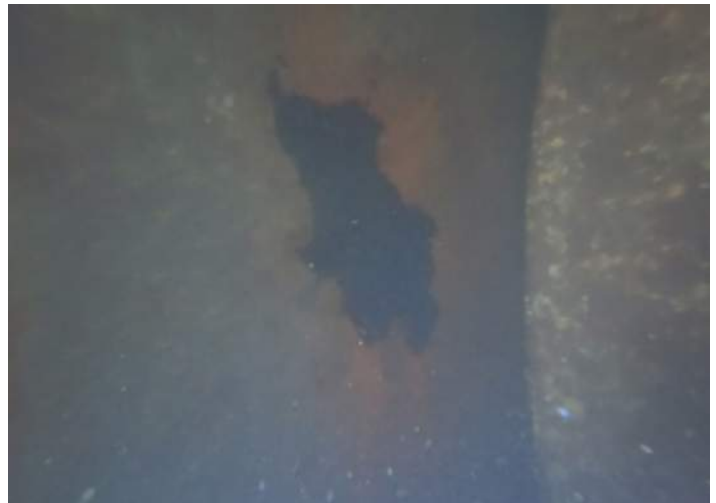
Image 17 – 12"x3' Hole South Side Cell

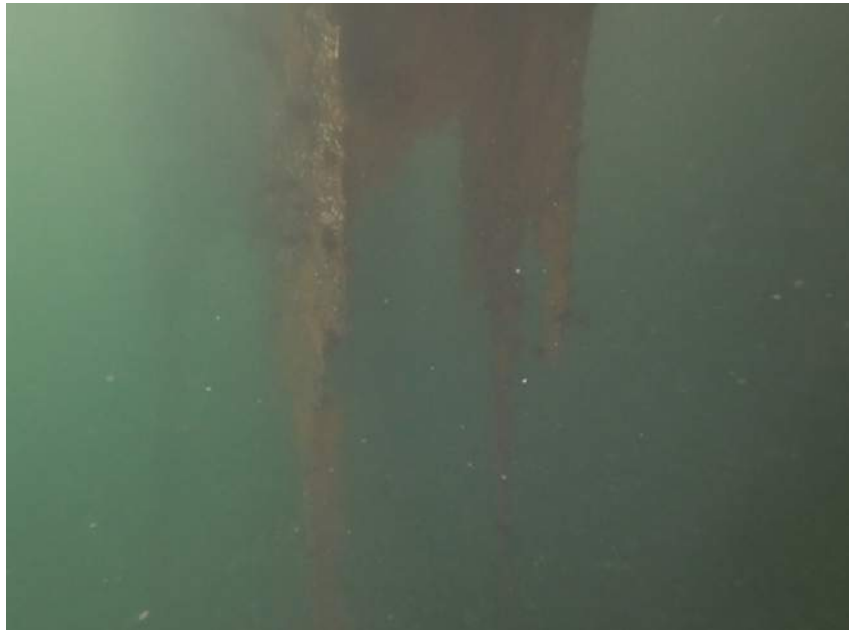
Image 20 – Typical H-Pile Condition at Slip Cells
