2021 Healy Canyon

186863-MBI-CE-RPT-001

Final Report

May 9, 2022

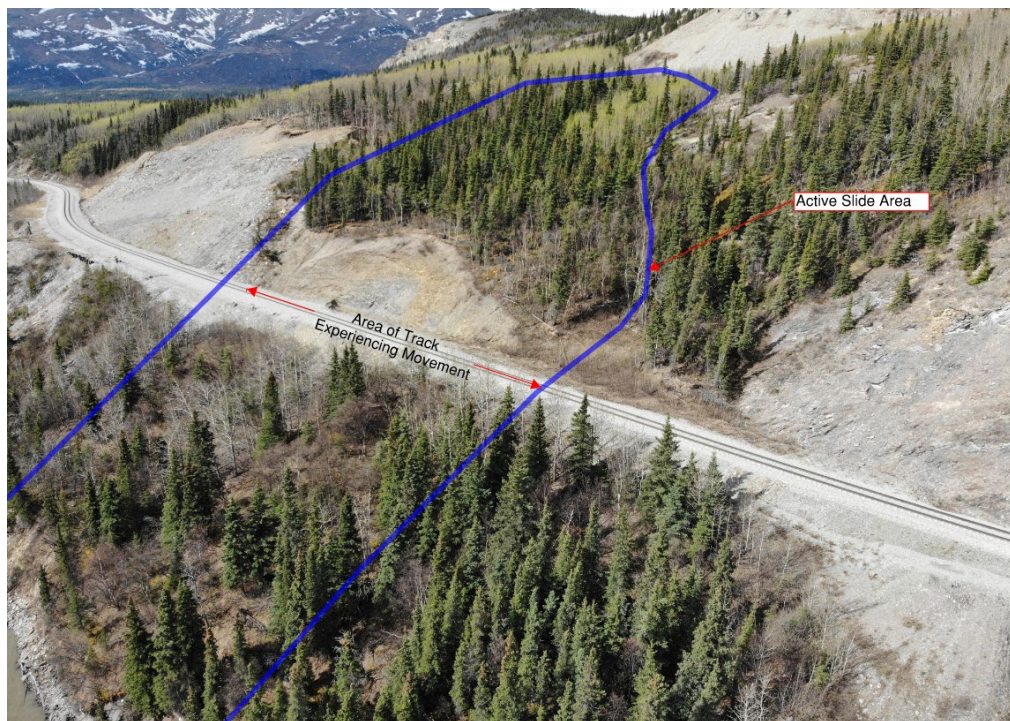
Figure 2-1: MP357.1 slope failure site layout and features

Slope movement at MP357.1 has been a long, ongoing problem requiring track realignments and frequent surfacing to maintain service through this dynamic area, with slope movement observed dating back to 1936. The tracks at the MP357.1 slope failure site are located on a bench cut into the side slopes of the west bank of the Nenana River. Re-alignment of the track to the west was performed as long ago as 1950 and most recently in 2010. The 2010 realignment provided horizontal offset from the edge of the canyon at MP356.9 at two aging retaining structures that suffered storm-related damage during disaster DR-1796. This 2008 mid-summer storm event with heavy rain resulted in downward movement of the slope. The 2010 realignment is thought to have inadvertently re-activated the historic landslide at MP357.1, requiring resurfacing with increasing frequency from 2013 to 2016, and continued maintenance efforts into 2021. Between 2010 and 2016, it was estimated that 5 to 7 feet of displacement downward toward the river had occurred. The MP357.1 Slope Failure report is included as Appendix B.

Drainage structures in the vicinity include a drop inlet on the inside ditch and a culvert just north of the slide area. The culvert was conveying flow during the May 18, 2021 site visit. The drop inlet has no apparent connection to an outlet on the downhill side of the track, though a relic culvert outlet is present. Slide movement has likely broken any connection between the inlet and outlet. Proper drainage is further impeded as little-to-no gradient is present in the ditch to direct flow to the drainage structures.

Drainage is recognized as the main contributor to the slope movement at MP357.1. Any slope stability solutions at this location should incorporate drainage improvements to intercept water before it enters the slide mass. Facilitating runoff conveyance to the other side of the track structure and ultimately down to the Nenana River reduces pore-water pressures and limits infiltration to the failure plane, where water can facilitate movement.

A combination of improved ditches, trench subdrains, culverts, and site earthwork are recommended. These improvements would be designed to capture and convey the surface runoff downslope and across the embankment.

- Grading the inside ditch to direct flow to newly-installed culverts and remove the existing “ditch plug” currently present. An impervious geosynthetic clay liner (GCL) is recommended in the base of the ditches to prevent infiltration through the ditch bottom.

- Removing, grouting, or repairing the existing drop inlet.

- Two additional trench drains, lower in the slope, are proposed to intercept surface water and drain the center of the slide mass. The regraded inside ditch should be lined with GCL to reduce infiltration into the subsurface.

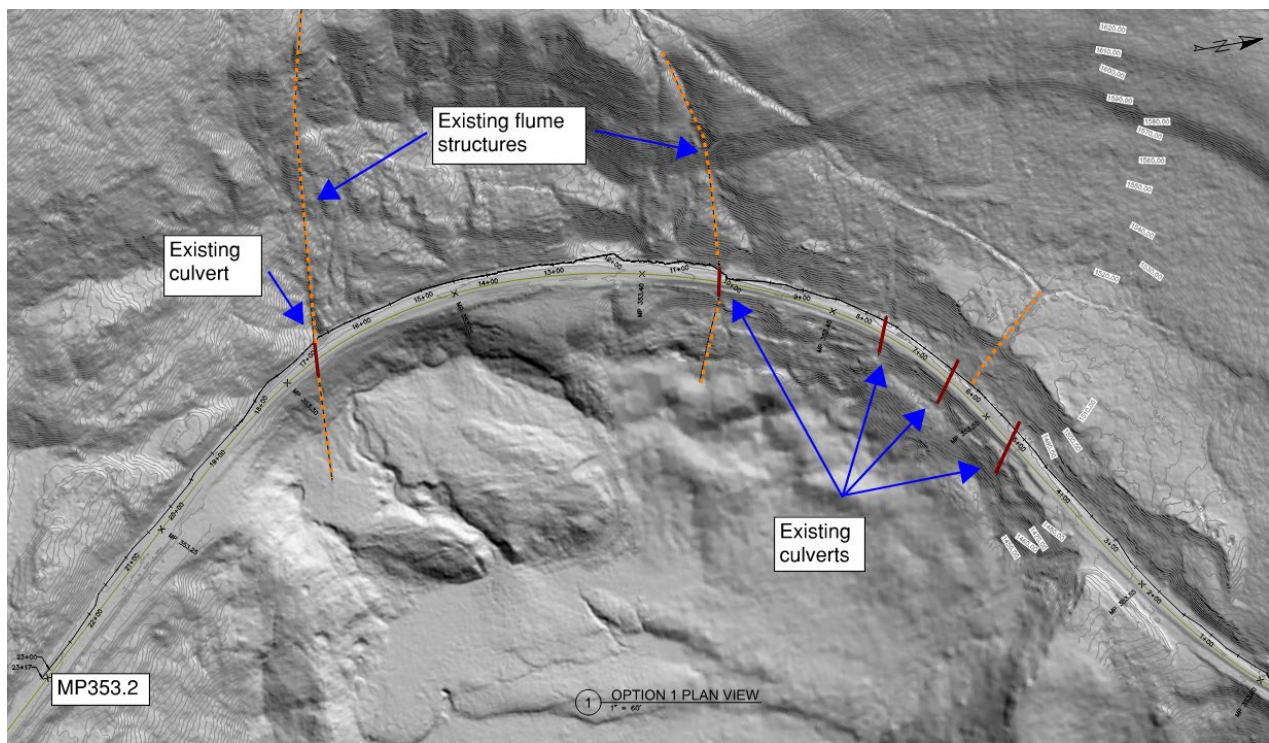
Figure 2-3: MP353.2 "Moody Slide" area and existing drainage structures

Another area of slope movement, MP353.2 (Moody Slide), has been an ongoing problem since the 1920s, requiring multiple track realignments resulting in a sharp curve in the alignment. Early efforts to control slope movement involved constructing drainage ditches and flumes to intercept and direct runoff downhill across the tracks, reducing infiltration in the active slide area. Slope movement over time has displaced sections of these ditches and flumes from their original positions. Though historical slope movement has been severe at times, the slope along the curve at MP353.2 has been relatively stable recently. Minimizing infiltration by improving drainage is considered the most cost-effective option to mitigating future slide activity. The curve and existing drainage features at MP353.2 are shown in Figure 2-3. The MP353.2 Slope Failure report is included as Appendix C.

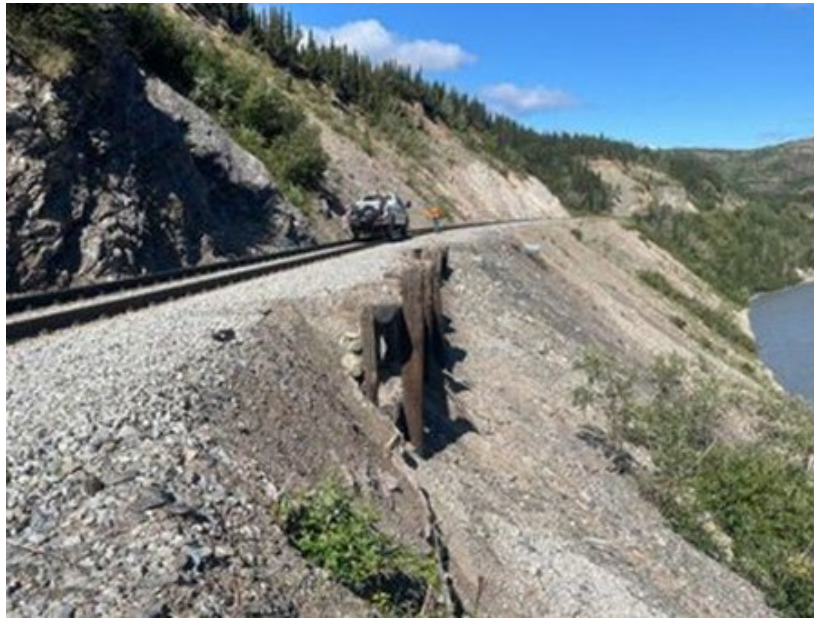
Figure 2-7: Wall # 41 - condition rating: poor

Wall 36 and Wall 41 are set in Phase 2 due to the high criticality of imminent wall failure. The main sections of both Wall 36 and Wall 41 are comprised of timber pile with cable tiebacks. Due to the steep nature of this location, workers and equipment can clear during construction both down-station (MP354.72) and up-station at the Road Access Area (MP356.13) that can be used as staging storage outside the foul zone. It is recommended to replace the damaged and decaying timbers on Wall 36. It is recommended to replace Wall 41 with soldier pile and lagging or steel sheet pile in front of the existing wall.

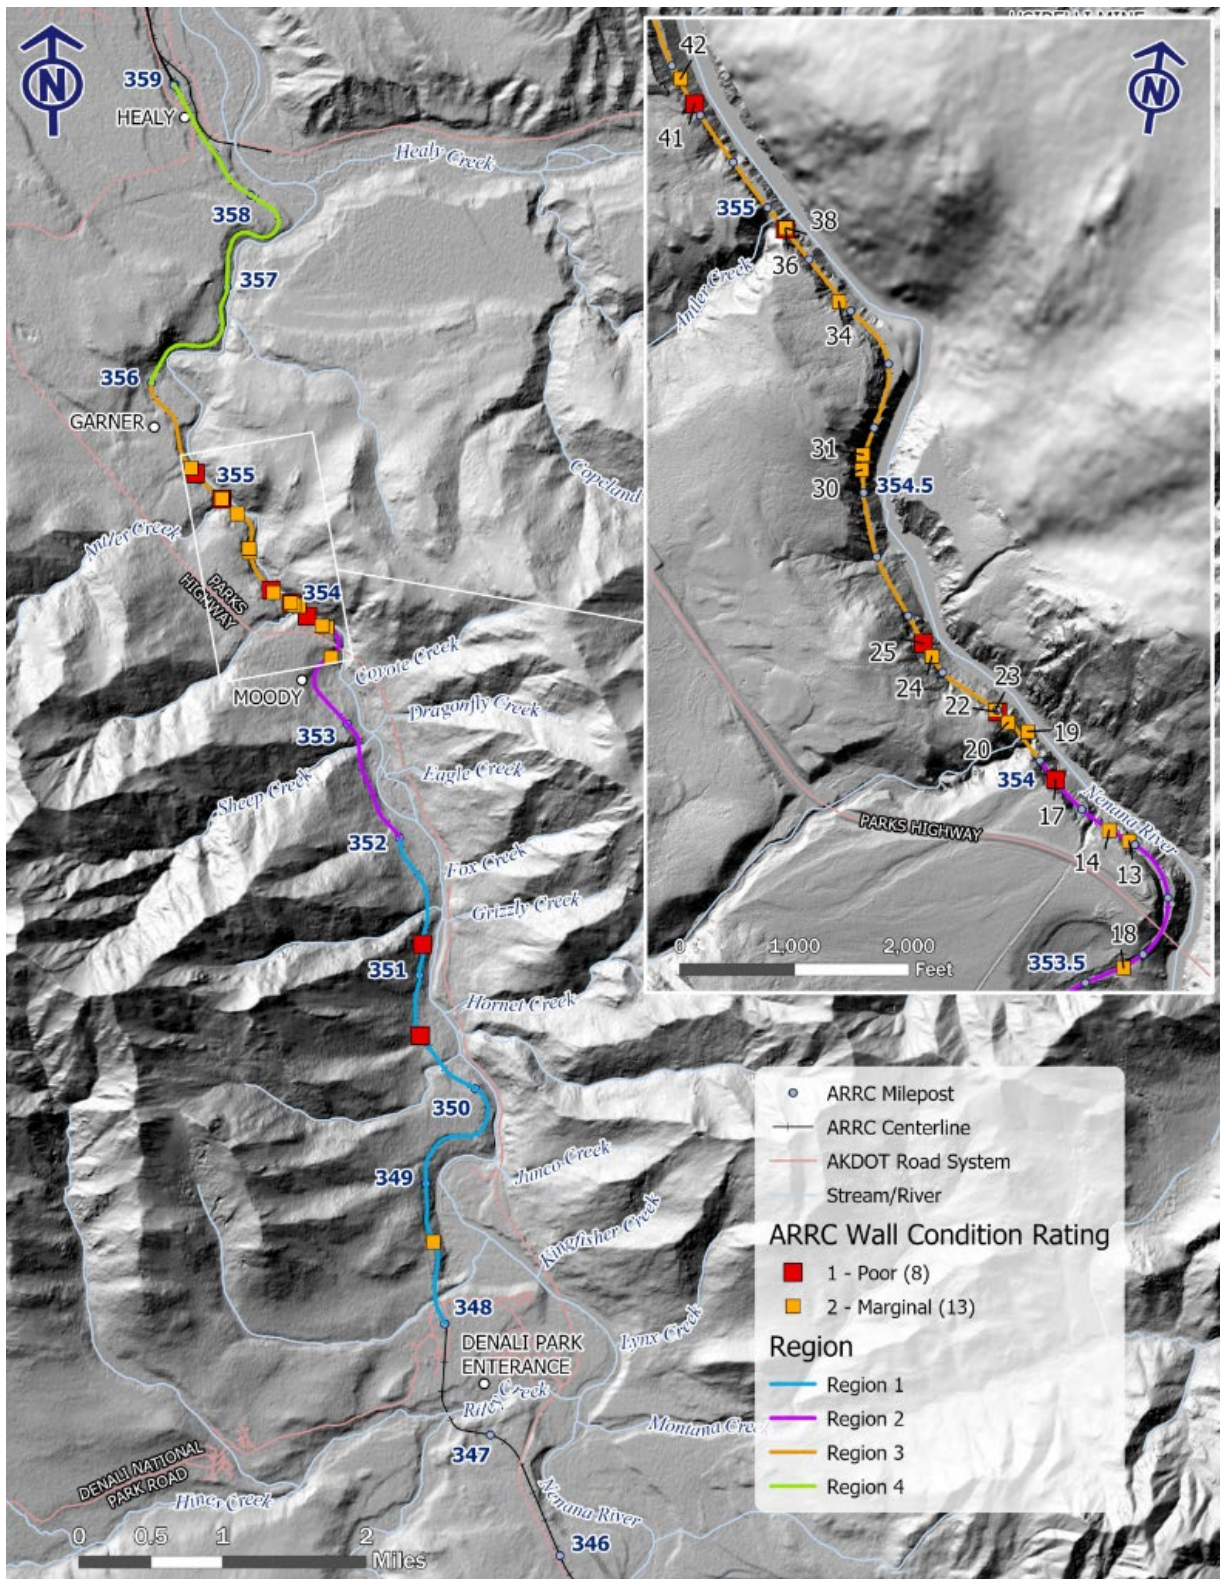
Figure 2-8: Marginal and poor rated retaining walls in Healy Canyon

Additional data was analyzed in order to filter the walls by criticality, region, recommended repair cost, and the ability to combine additional wall projects in the immediate vicinity. Four moderately proportional regions were created based on ease of accessibility between MP348 and MP361. Region 1 is adjacent to the Denali Park road access point and Region 4 is adjacent to the Healy Yard access point and were considered the most convenient in terms of access to the main entries. A potential third construction point of entry at MP355.88 was also considered in Region 3. The following section utilized these regions to finalize and prioritize repair recommendations into phases for the seven walls that received a 1 (poor) condition rating. Table 2.2 provides the spread of wall condition states across the regions and Figure 2-8 represents the retaining walls rated marginal and poor throughout the canyon.

ARRC has seven retaining walls with a poor condition rating between Denali National Park and Healy Yard; these poor walls are critically damaged or in need of immediate repair and are well past their useful life. Below, the walls have been divided into phases.

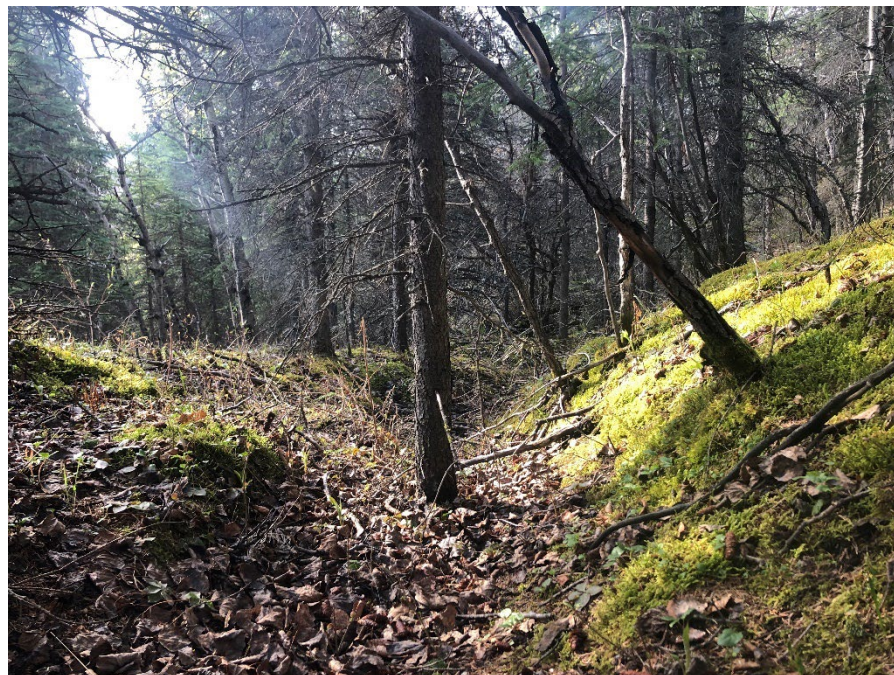
Figure 2-2: Tension cracks or grabens buried in debris, May 18, 2021

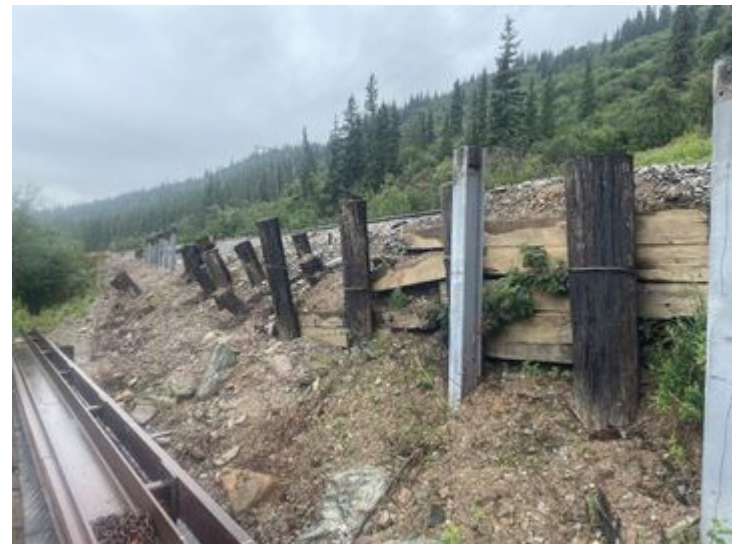
Wall 3 and Wall 25 have been set in Phase 1 due to the simplicity of repair/replacement. The existing Wall 3 main structural section is comprised of a timber pile wall system with cable tiebacks. The north end of the wall is already in the process of being replaced with a soldier pile wall. On the right side of tracks there is potential to have a work area that can be used as staging storage outside the foul zone, where workers and equipment can clear during construction. Since there is new construction going on, it is assumed no engineering work or additional design would need to be done to complete the wall.

Comments:	Demonstrating the distance between existing wall and new wall	Date:	7/29/2021	Comments:	Typical failure of piles and lagging	Date:	7/29/2021
		photo:	9			Photo:	10
Wall # 3 Wall Condition Rating: Poor		MP #:	350.72	Wall # 3 Wall Condition Rating: Poor		MP #:	350.72

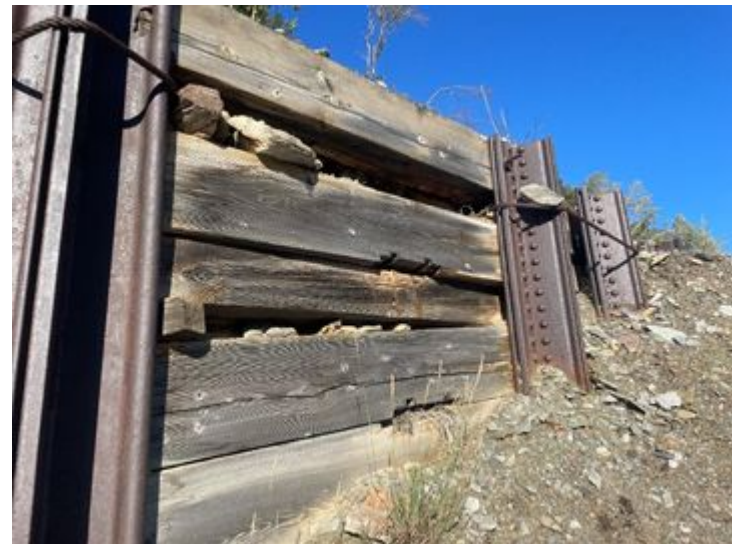
The existing Wall 25 main structural section is comprised of a soldier pile wall with timber lagging and cable tiebacks. The top timber lagging is missing and the remainder is failing. Wall 25 is in Phase 1 for the simplicity of the fix and lack of major equipment. The main structure components that require engineering, large equipment, and major track shutdowns (the steel piles and cable tiebacks) appear to be in solid condition and can be reused. Only the timber lagging will need to be replaced.

Comments:	Missing timber with gravel spilling through	Date:	7/29/2021	Comments:	Misaligned timbers with gaps with gravel spilling	Date:	7/29/2021
		photo:	9			Photo:	10
Wall # 25 Wall Condition Rating: Poor		MP #:	354.26	Wall # 25 Wall Condition Rating: Poor		MP #:	354.26

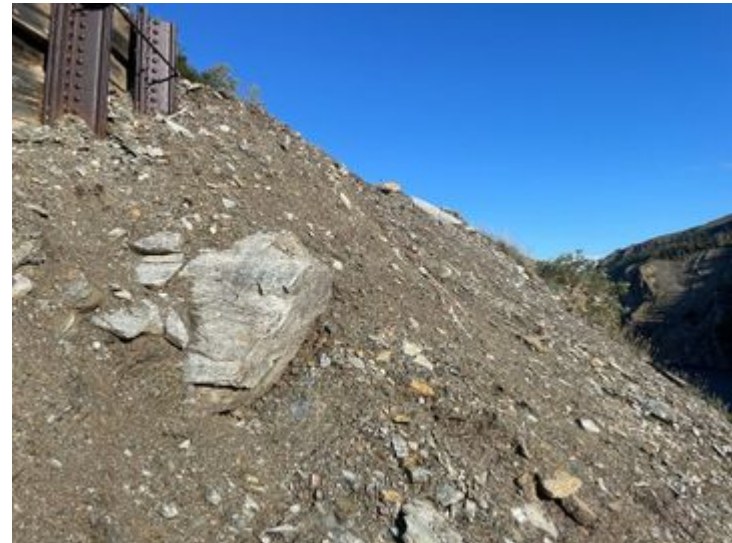
Comments:	Minor corrosion no measurable section loss	Date:	7/29/2021	Comments:	Typical	Date:	7/29/2021
		photo:	11			Photo:	12
Wall # 25 Wall Condition Rating: Poor		MP #:	354.26	Wall # 25 Wall Condition Rating: Poor		MP #:	354.26

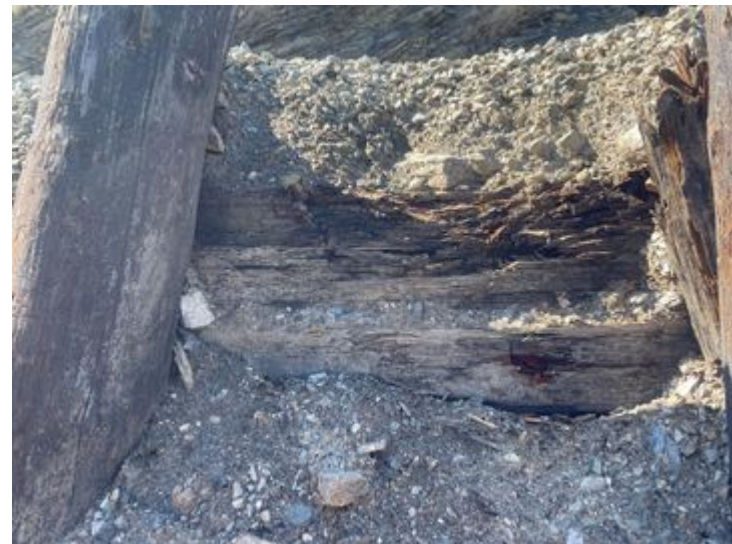
Comments:	Hollow sounding for entire height of exposed pile with splitting and decay	Date:	7/29/2021	Comments:	Lateral member decay	Date:	7/29/2021
		photo:	9			Photo:	10
Wall # 41 Wall Condition Rating: Poor		MP #:	355.41	Wall # 41 Wall Condition Rating: Poor		MP #:	355.41

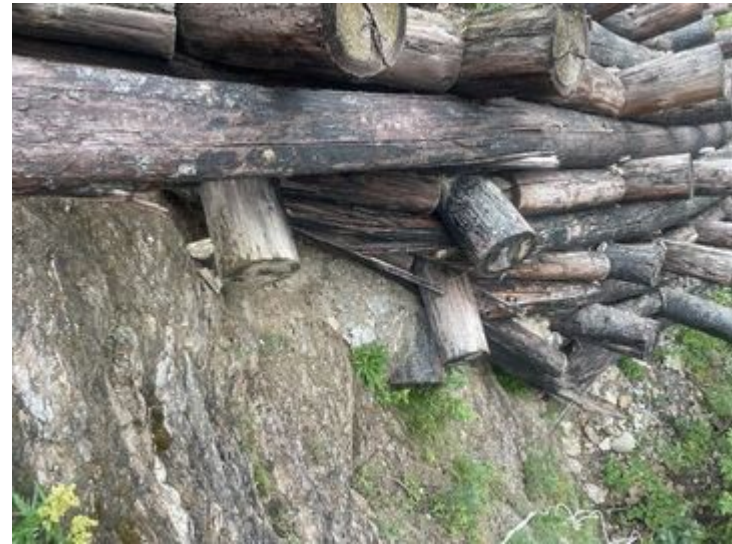
Comments:	Failure of lateral cribbing members typical	Date:	7/28/2021	Comments:	Failure of lateral cribbing members typical	Date:	7/28/2021
		photo:	7			Photo:	8
Wall # 22 Wall Condition Rating: Poor		MP #:	354.1	Wall # 22 Wall Condition Rating: Poor		MP #:	354.1

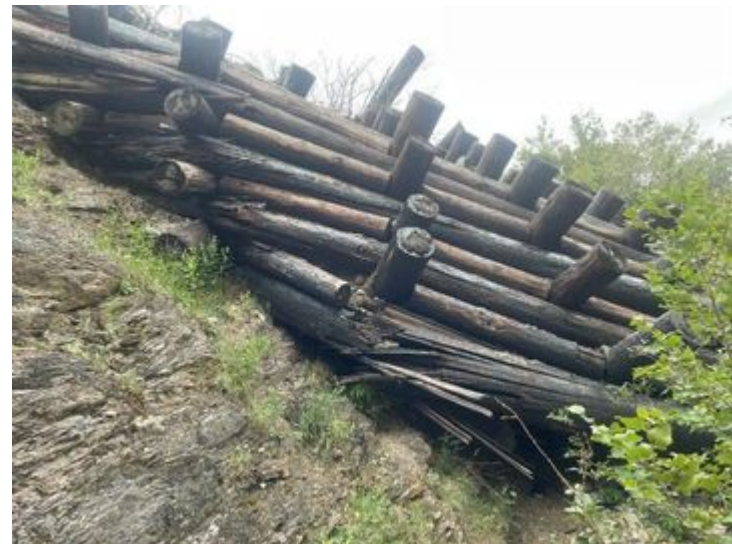
Comments:	Dislodged members with rock ball	Date:	7/28/2021	Comments:	Under cutting slope failure while shifting down	Date:	7/28/2021
		photo:	9			Photo:	10
Wall # 22 Wall Condition Rating: Poor		MP #:	354.1	Wall # 22 Wall Condition Rating: Poor		MP #:	354.1

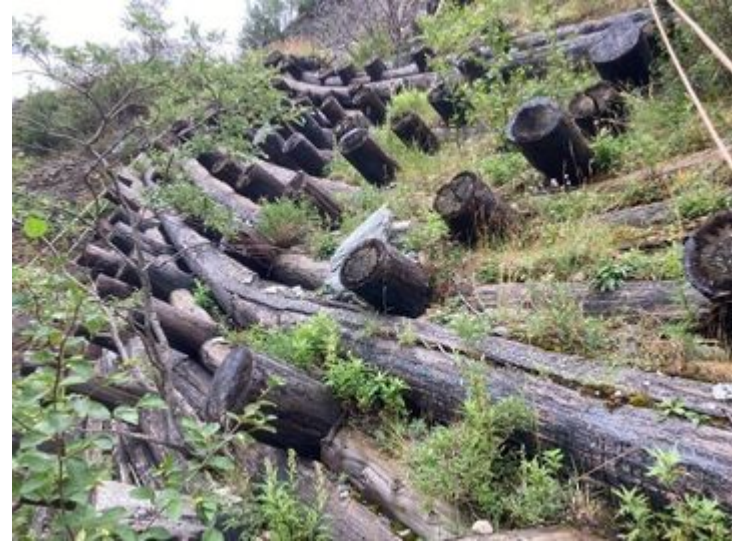
Comments:	Dislodged members with rockfall	Date:	7/28/2021	Comments:	Typical elevation	Date:	7/28/2021
		photo:	11			Photo:	12
Wall # 22 Wall Condition Rating: Poor		MP #:	354.1	Wall # 22 Wall Condition Rating: Poor		MP #:	354.1
Comments:		Date:	7/28/2021	Comments:		Date:	7/28/2021
		photo:	13			Photo:	14
Wall # 22 Wall Condition Rating: Poor		MP #:	354.1	Wall # 22 Wall Condition Rating: Poor		MP #:	354.1

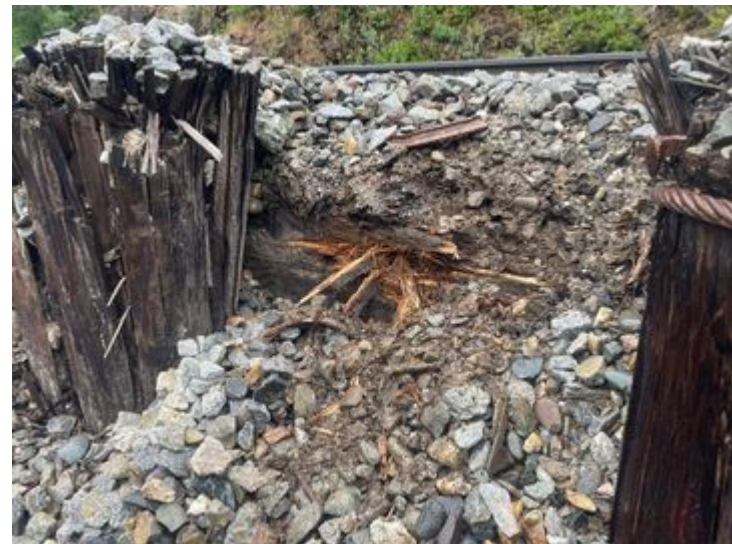
Comments:	25%-50% section loss/decay/rot	Date:	7/28/2021	Comments:	Up to 100% section loss/decay/rot	Date:	7/28/2021
		photo:	9			Photo:	10
Wall # 4 Wall Condition Rating: Poor		MP #:	351.2	Wall # 4 Wall Condition Rating: Poor		MP #:	351.2
