Whittier Tunnel Surface Improvements

Portage Glacier Road Whittier, AK|*** 99510

Date Sun 03/14/2021

Job # 119776

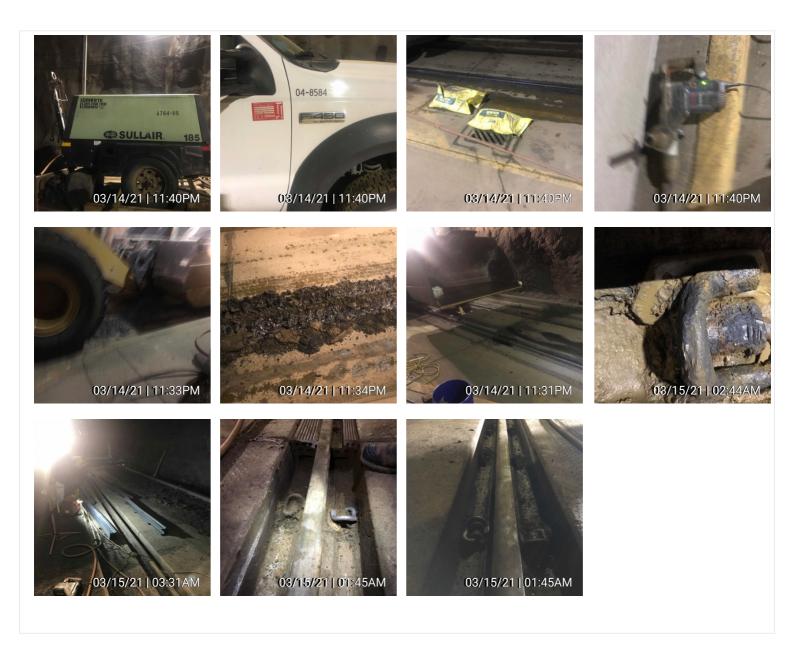
Work Logs					
Name	Description	Quantity	Total Hours	Total Hours To Date	
ARRC Crew	Ian Pierce - flagger - form B - r3434 Gabriel Thomas - PM - R3612 R3434 needs an oil change. Suggest take to anchorage in the AM and return in evening. Would like to do this when fuel tank is low to maximize fuel prices in anchorage. Gabriel Thomas 03/15/21 12:02AM	2	17	17	
Granite Crew	Ripped asphalt on north rail (on safe house side of track) starting in front of, and north of safe house 8 and replaced with rubber flange filler. SH 8, two / three passes with loader bucket teeth mounts. 38% of eclipse are broken on first 5 panels, less are broken track north of SH8 13 panels of production. Starting 2 panels north of phone 582 Slight damage to concrete in tubs. Need to keep an eye	8	68	171.5

on it.			
	Rubber installation is smooth, no D clips, D clips will present a challenge for installation			
	Asphalt removal is damaging the joint seals, joint seals appear to be in bad shape to start with.			
	Granite has excavator on order			
	Gabriel Thomas 03/15/21 12:22AM			
Whittier Tunnel Inspection and Daily Reporting		0	0	0
Total		10	85	188.5
