11.30.18 Earthquake Emergency Repairs

Saturday, December 01, 2018

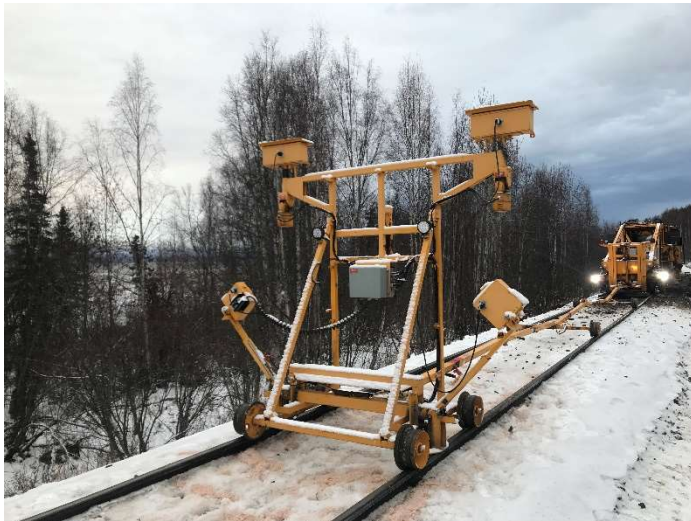
Photo 3: The ET20 realigning and raising the rail at ≈MP138.5, looking RR North-Northwest.

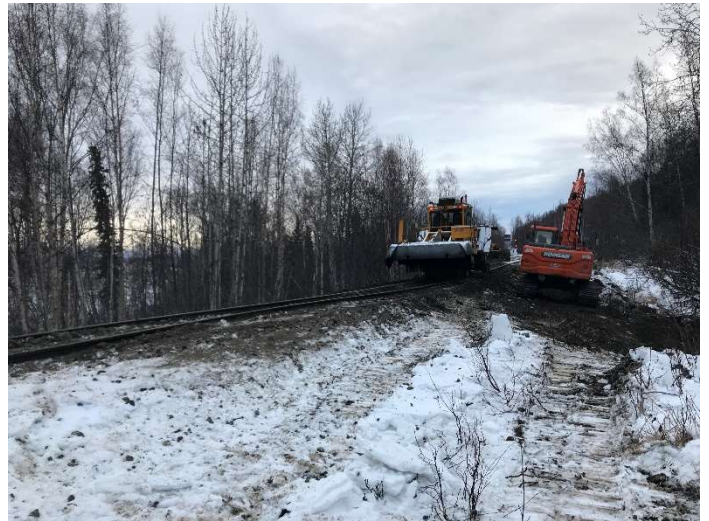
Photo 4: The BR20 and the DX180LC working at the ≈MP 138.5 worksite, looking RR North.
