# ALASKA Daily Construction Report

### 11.30.18 Earthquake Emergency Repairs

Saturday, December 01, 2018 Shift: 0700 to 2000

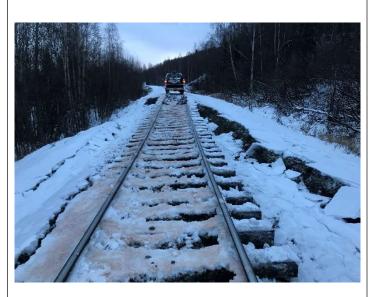
Photo 1: Ice melt placed above the mainline at ≈MP 138.5, looking RR North.

Procured ice melt from Lowes in Wasilla, AK and transported to the ≈MP 138.5 disaster site. Ice melt was placed above ≈126 feet of rail within the depression. Material was removed from between ties using hand tools to allow track crews to jack and shim the affected section of rail closer to its pre-disaster elevation.

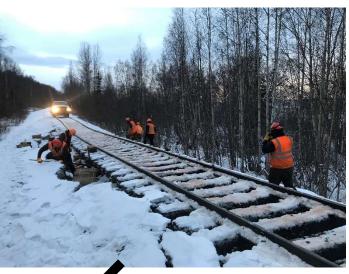
orces jacking and shimming the Photo 2: ARR affected section 138.5, looking RR South-Southwest.

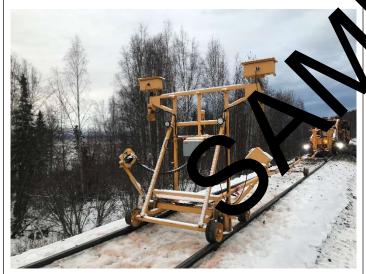
Photo 3: The ET20 realigning and raising the rail at ≈MP138.5, looking RR North-Northwest.

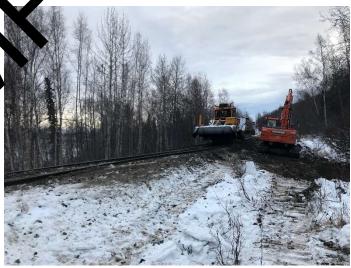
Photo 4: The BR20 and the DX180LC working at the ≈MP 138.5 worksite, looking RR North.
