- 5. AFTER SIDE SHEET REMOVAL, SIDESILL CORROSION MUST BE REMOVED WITH GRIT BLASTING TO WHITE METAL SURFACE THEN PAINTED WITH WELD-THROUGH PRIMER PRIOR TO REPLACING SHEETING.

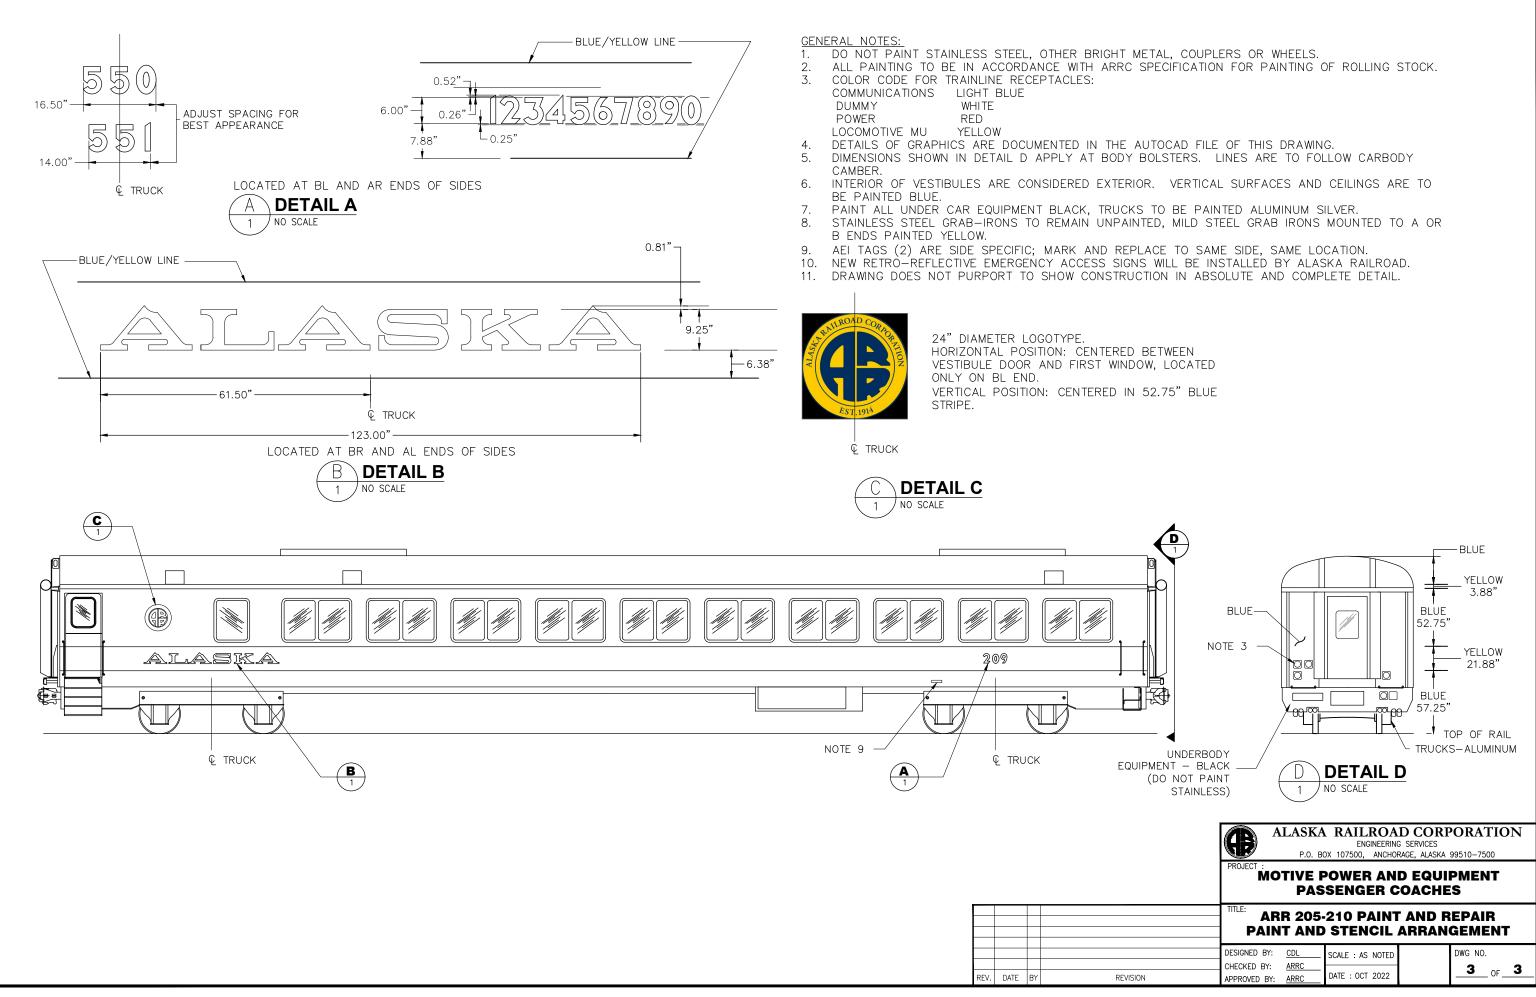
MOTIVE POWER AND EQ PASSENGER COAC	HES
ARR 205-210 PAINT AND DETAILS AND NOT	
Image: Constraint of the second sec	DWG NO. 2 OF 3
