2021 Healy Canyon

186863-MBI-CE-RPT-001

Final Report

May 9, 2022

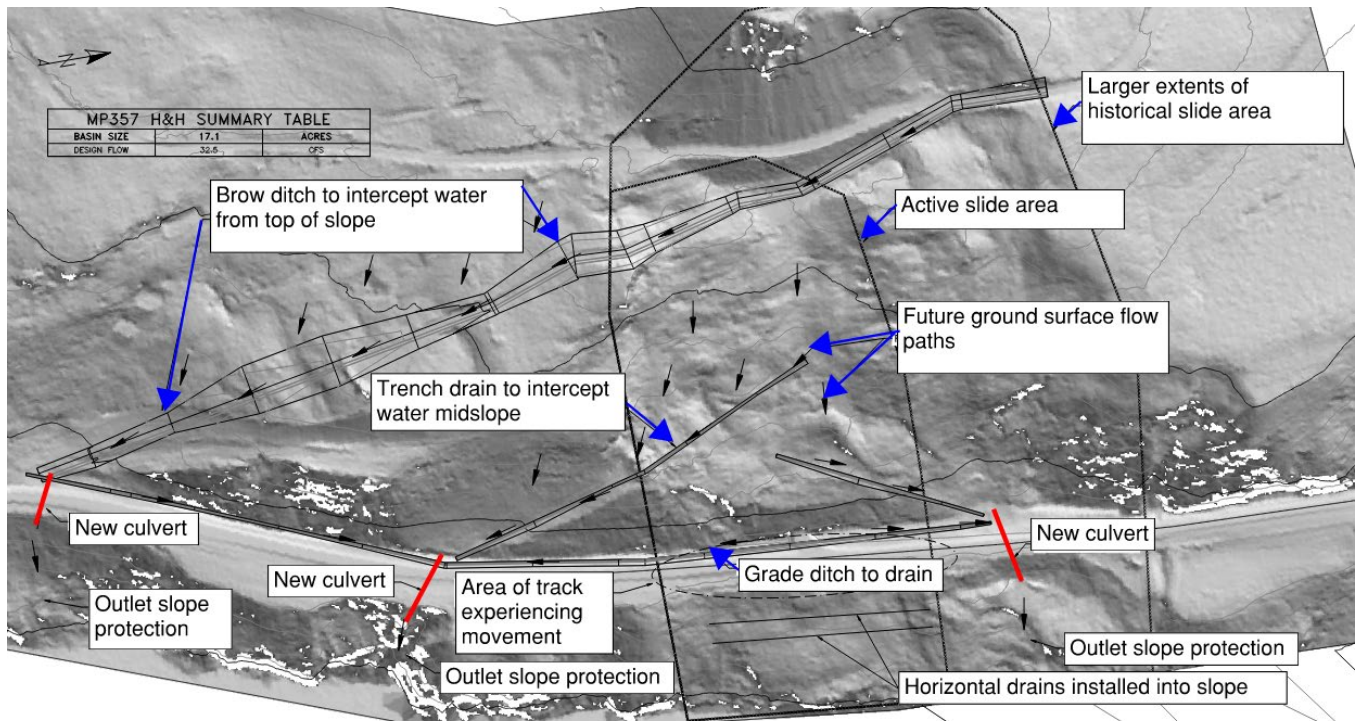
Figure 2-2: MP357.1 proposed drainage improvements

A combination of improved ditches, trench subdrains, culverts, and site earthwork are recommended. These improvements would be designed to capture and convey the surface runoff downslope and across the embankment.

- Grading the inside ditch to direct flow to newly-installed culverts and remove the existing “ditch plug” currently present. An impervious geosynthetic clay liner (GCL) is recommended in the base of the ditches to prevent infiltration through the ditch bottom.

- Removing, grouting, or repairing the existing drop inlet.

- Two additional trench drains, lower in the slope, are proposed to intercept surface water and drain the center of the slide mass. The regraded inside ditch should be lined with GCL to reduce infiltration into the subsurface.

- Horizontal drains installed in an array below the track some distance into the slope and sloped appropriately. These should be installed below the track to limit icing at the track in the winter. Horizontal drains should consist of hollow pipe with perforations wrapped in a geotextile.

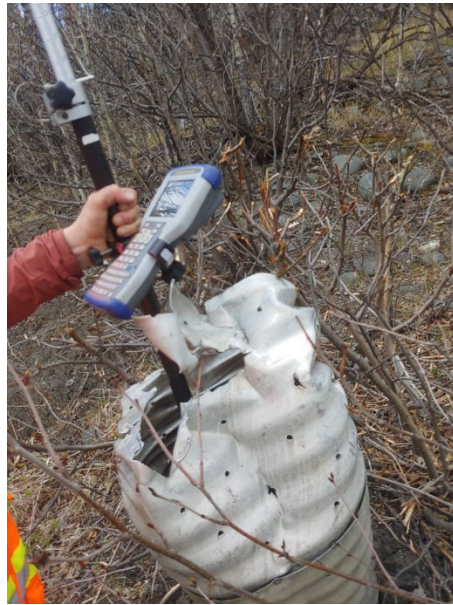
The remainder of this section focuses on the five culverts rated in poor condition and in need of immediate repair. The condition rating of poor was assigned to culverts within Healy Canyon due to either the inlet or outlet being completely buried or filled with debris. All culverts found to be in poor condition are round CMP material. Two vertical CMP rated in poor condition, inventoried near MP353.5, are within the MP353.2 slope failure project area. Ground movement within this area has pushed the perforated inlets of both culverts above grade 1.5 to 2.5 feet. The CMP at MP353.48 is shown in Figure 2-9. Figure 2-10 shows the location of the five culverts rated in poor condition within the project extent.

Figure 2-9: Vertical 12-inch CMP rated in poor condition at MP353.48

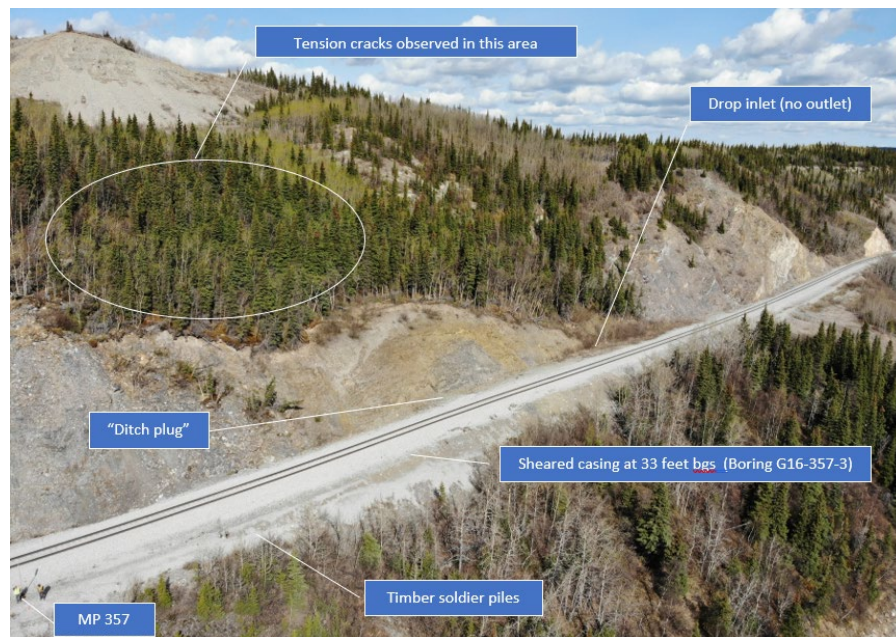
During a second site visit on May 18, Michael Baker confirmed the depth of the slip surface, inspected the slide area for potential areas contributing to water infiltration, and generally assessed the slide area. Rebar was lowered into the casing at BH-3, where it encountered soil approximately 30-33 feet below grade where the casing installed in 2016 had sheared. Throughout the slide area and near the head of the slide area, tension cracks or depressions (grabens) running transverse to the slope were noted as a possible avenue of infiltration. The grabens observed were masked by surface debris and vegetation, suggesting the slide movement is both old and slow. No rotation was noted in the trees on the hillside that would otherwise suggest rotational movement or circular slip surface. These observations further support characterizing the

slide as a translational slide. Slide features are called out in Figure 2-1. Tension crack features are shown in Figure 2-2.

Figure 2-1: MP357.1 slope features, May 18, 2021

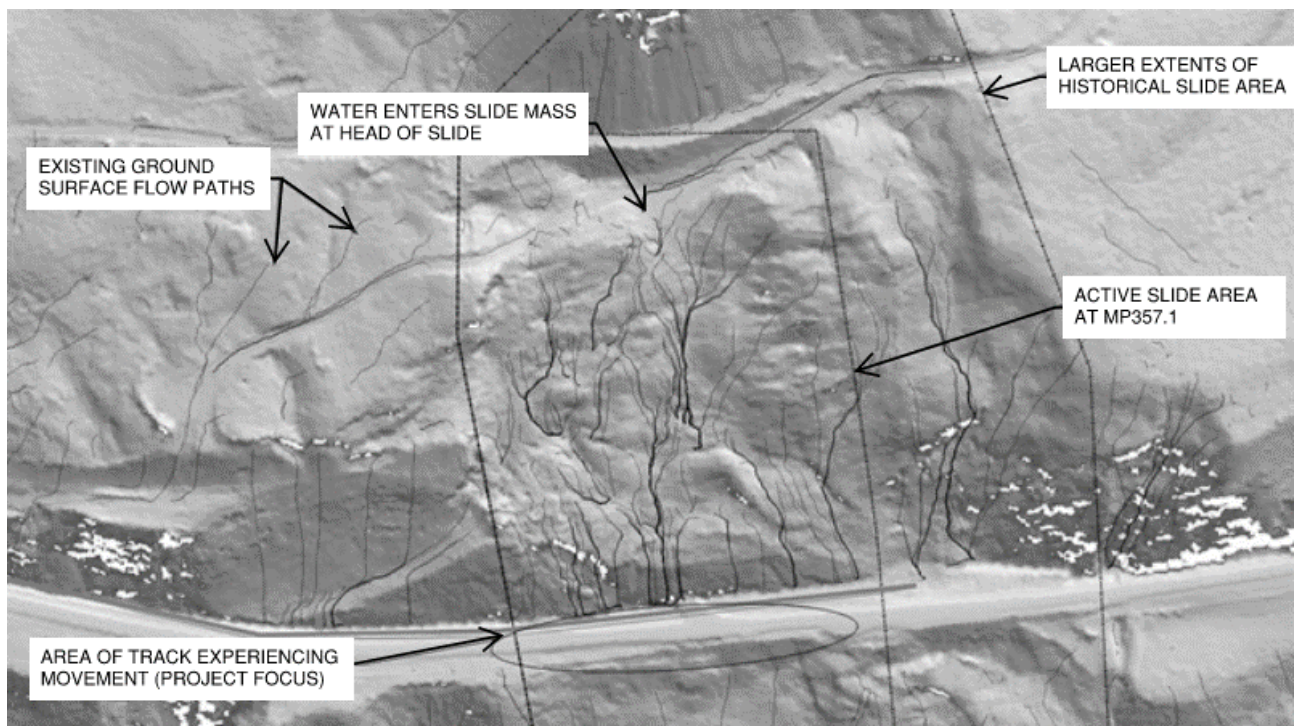
An analysis of the surface water flow paths, based on the LiDAR DEM surface, indicate surface water flow paths are concentrated-in and align-with the areas of observed slope movement. Slide features, topography and active slide extents identified from the LiDAR are shown in Figure 2-3.

Figure 2-3: Drainage flowpaths derived from the LiDAR DEM at MP357.1

The orientation of flowpaths suggest the access road at the head of the slide area promotes drainage of surface water into the slide mass. The darker lines in Figure 2-3 indicate areas where flow paths tend to converge; these paths coincide with the center of the active slide area.

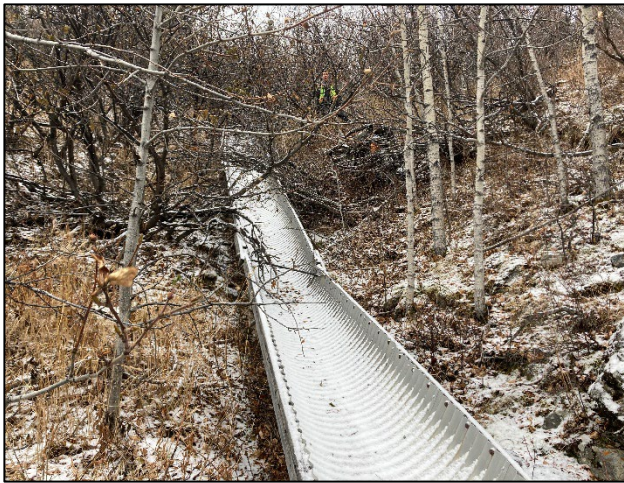
- Three flumes within the study area are referred to as the **Southern Flume**, the **Middle Flume**, and the **Northern Flume** in accordance with their relative positions (Photo 2.1). All flumes in their current state are considered non-functional (Photo 2.2). The Southern and Middle Flumes lead directly to culverts and the Northern Flume has two nearby culverts with perforated risers.

Photo 2.1: Existing flume west of the tracks, looking south

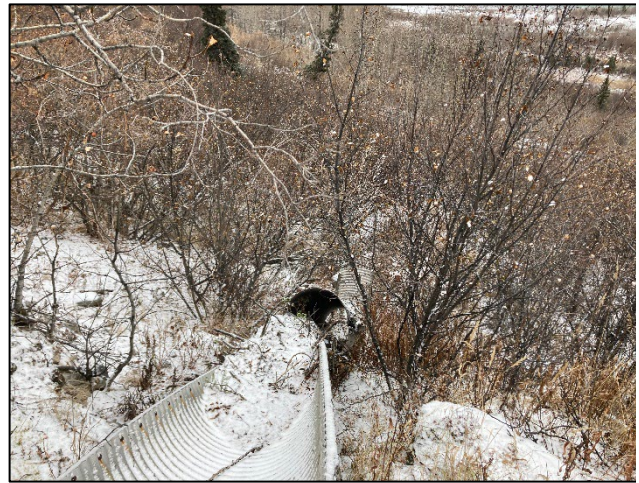
Photo 2.2: Section of disconnected pipe in the Middle Flume, looking north

Tier 3 extends and the Upper Ditch further south along the Upper Bench Rim and improves the Upper Ditch which conveys drainage to the Middle Flume. Tier 3 would rehabilitate the existing Middle Flume structure through repairs to the flume and by enhancing the inlet conditions where water conveyed by the ditch enters the flume.

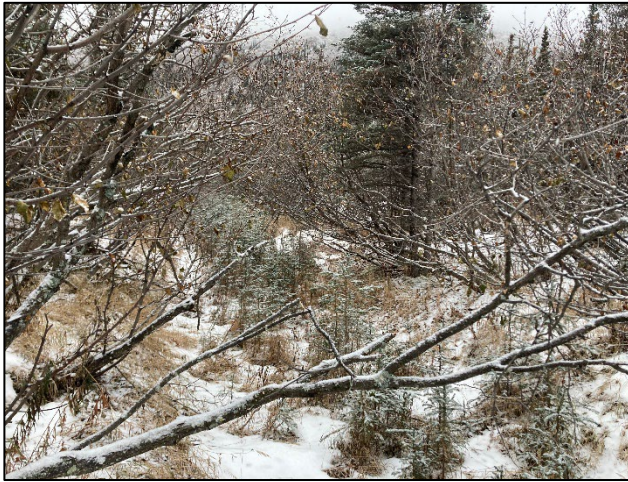
- The **Birch Creek Ditch** refers to the large north-south orientated ditch west of the track between MP353.4 and MP353.6 (Photo 2.3). This ditch is adjacent to the track about 800-ft

Photo 2.3: Birch Creek Ditch near MP353.6, looking south

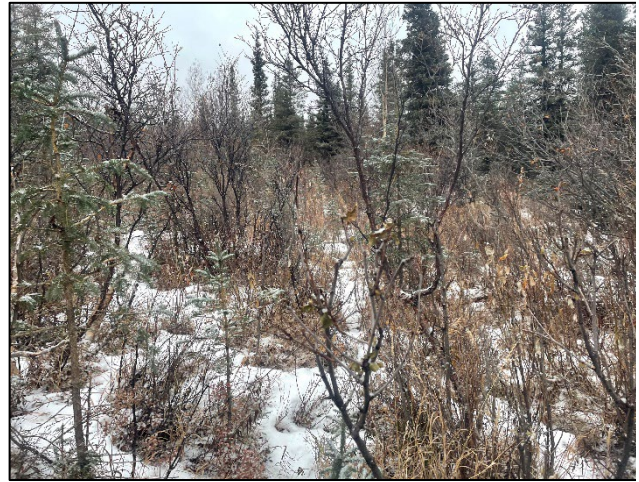
- The **Upper Ditch** system refers to two ditches on the Upper Bench running adjacent and perpendicular to the Upper Bench Rim which converge above the Middle Flume (Photo 2.4). Improvements to this ditch are recommended as part of Option 3.

Photo 2.4: The Upper Ditch and Rim, looking west

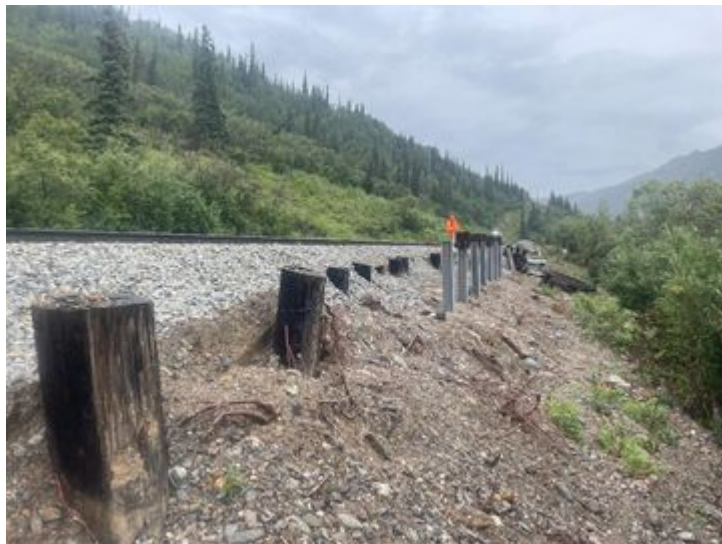
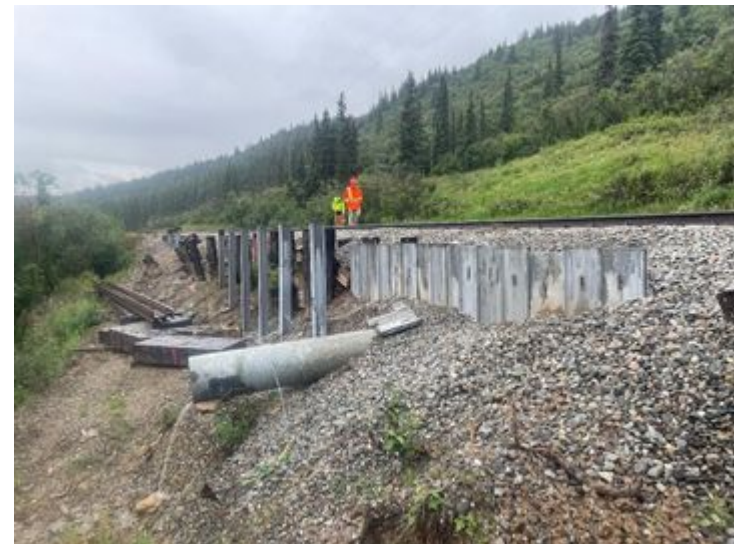
Comments:	Photo of Approach to Wall Start Looking Up Station	Date:	7/29/2021	Comments:	Photo of Approach to Wall Start Looking Down Station	Date:	7/29/2021
		photo:	1			Photo:	2
Wall # 3 Wall Condition Rating: Poor		MP #:	350.72	Wall # 3 Wall Condition Rating: Poor		MP #:	350.72

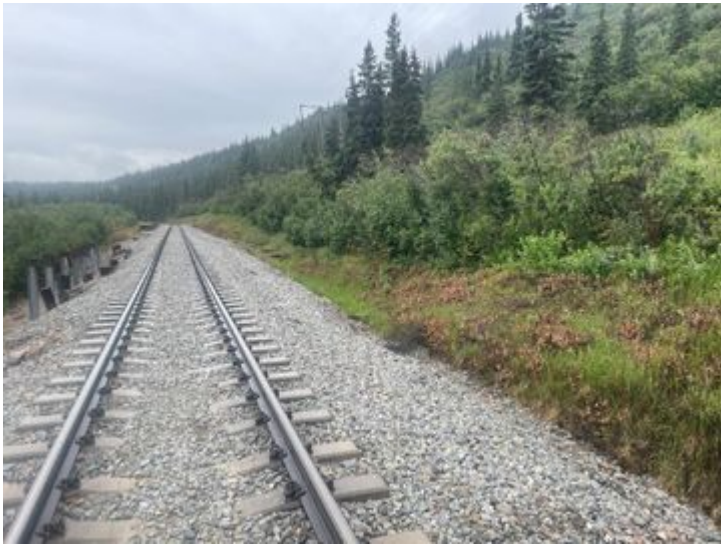
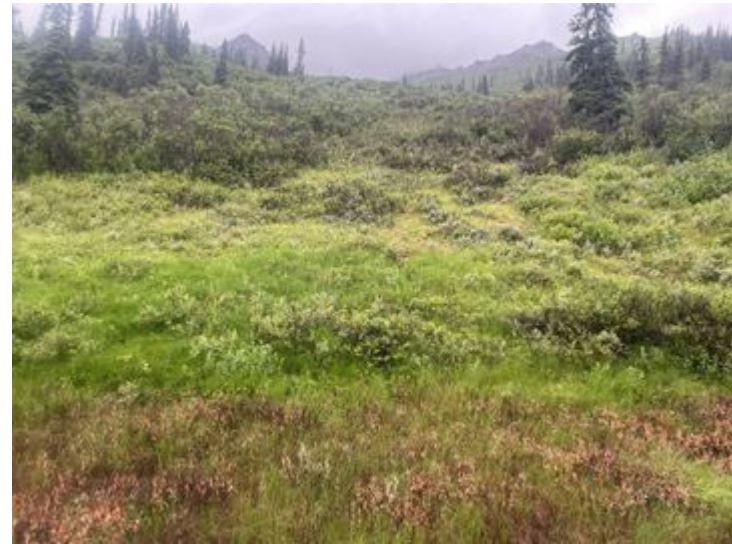
Comments:	Center Point of Wall/Track Centerline 360 Photo 1	Date:	7/29/2021	Comments:	Center Point of Wall/Track Centerline 360 Photo 2	Date:	7/29/2021
		photo:	3			Photo:	4
Wall # 3 Wall Condition Rating: Poor		MP #:	350.72	Wall # 3 Wall Condition Rating: Poor		MP #:	350.72

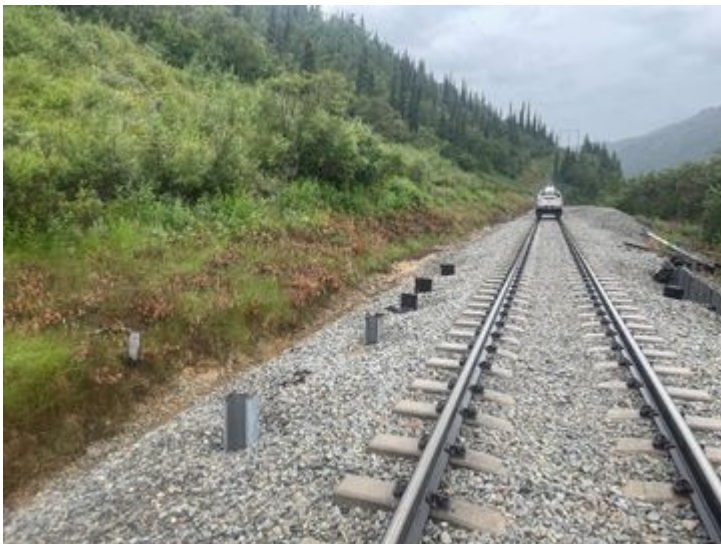
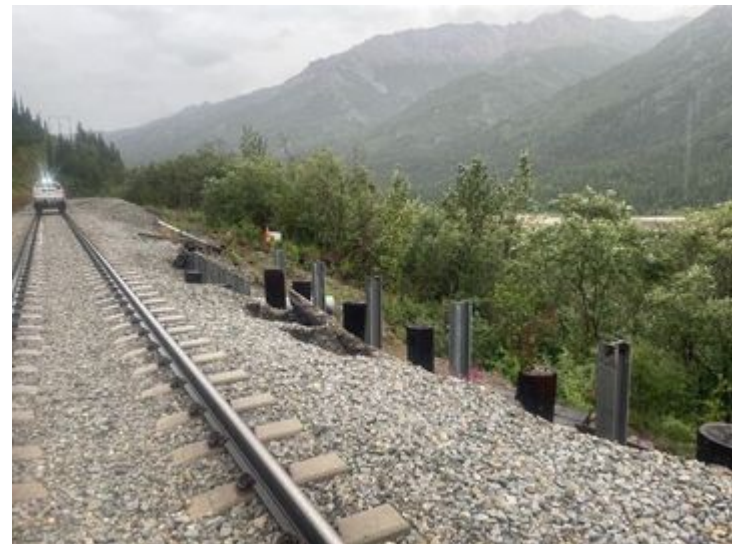
Comments:	Center Point of Wall/Track Centerline 360 Photo 3	Date:	7/29/2021	Comments:	Center Point of Wall/Track Centerline 360 Photo 4	Date:	7/29/2021
		photo:	5			Photo:	6
Wall # 3 Wall Condition Rating: Poor		MP #:	350.72	Wall # 3 Wall Condition Rating: Poor		MP #:	350.72

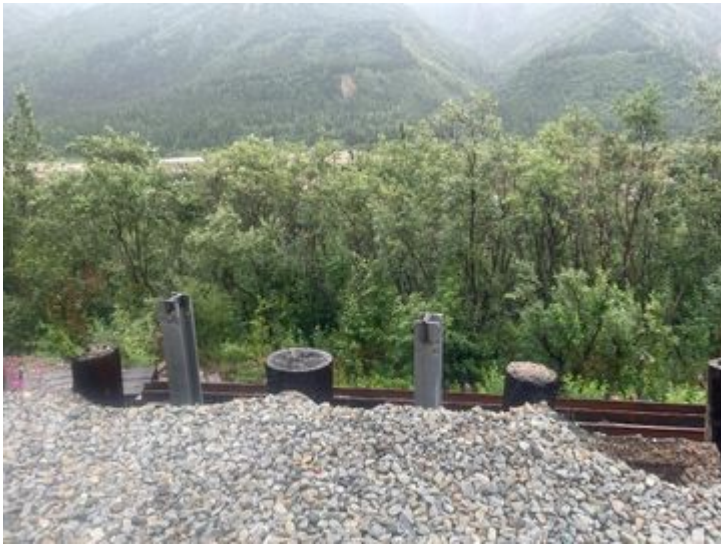
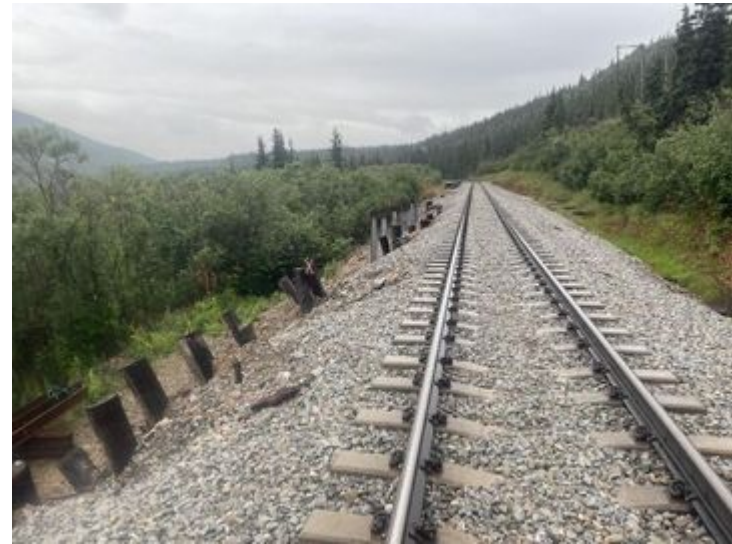
Comments:	Center Point of Wall/Track Centerline 360 Photo 5	Date:	7/29/2021	Comments:	Center Point of Wall/Track Centerline 360 Photo 6	Date:	7/29/2021
		photo:	7			Photo:	8
Wall # 3 Wall Condition Rating: Poor		MP #:	350.72	Wall # 3 Wall Condition Rating: Poor		MP #:	350.72

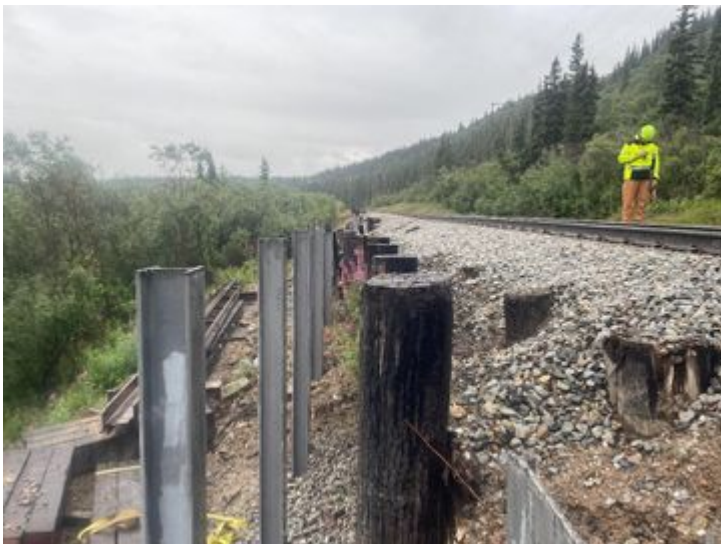
Comments:	Demonstrating the distance between existing wall and new wall	Date:	7/29/2021	Comments:	Typical failure of piles and lagging	Date:	7/29/2021
		photo:	9			Photo:	10
Wall # 3 Wall Condition Rating: Poor		MP #:	350.72	Wall # 3 Wall Condition Rating: Poor		MP #:	350.72

Area surrounding the wall appears to be sliding with indications of loose/failing tiebacks causing the wall to rotate.

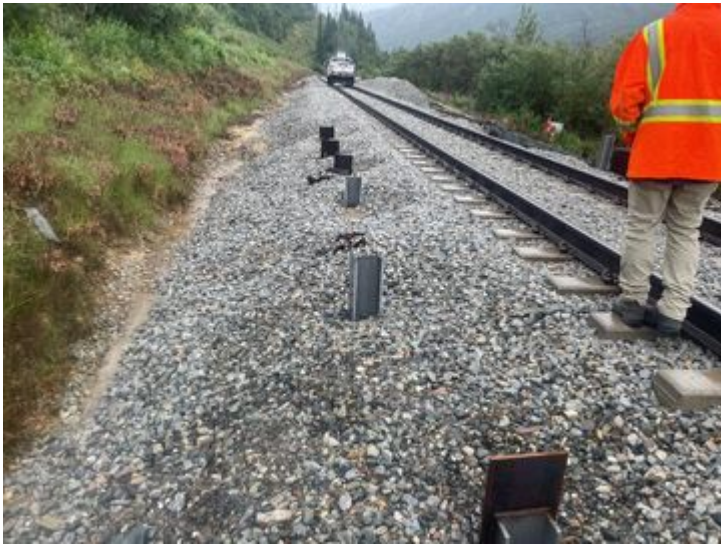
Comments:	Tieback piles exposed	Date:	7/29/2021
		photo:	11
Wall # 3	Wall Condition Rating: Poor	MP #:	350.72

- Piles-Timber piles exhibit section failure and are in need of replacement, steel piles, and sheet piles to remain.
- Lagging-Segments are missing or exhibit section failure and need replacement.
- Tiebacks-Timber tiebacks anchors are exposed, exhibit surface section failure, and need rehabilitation and/or replacement. Further investigation is required to determine if steel cable tiebacks are to remain.

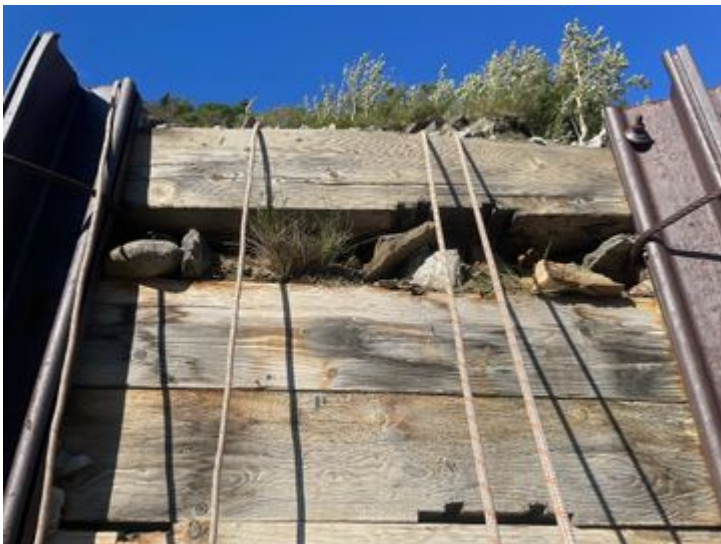
Comments:	Missing timber with gravel spilling through	Date:	7/29/2021	Comments:	Misaligned timbers with gaps with gravel spilling	Date:	7/29/2021
		photo:	9			Photo:	10
Wall # 25 Wall Condition Rating: Poor		MP #:	354.26	Wall # 25 Wall Condition Rating: Poor		MP #:	354.26

- Piles-Steel piles to remain.
- Timber Lagging- missing and misaligned, causing gaps allowing gravel to spill through and failing to provide lateral support. Top lagging may have allowed backfill and slope to erode. Lagging needs to be replaced.
- Tiebacks-Steel cabling to be reused.

Repair and replace missing/broken timbers and lengthen wall on both ends. Long term solution replace wall with a new anchored soldier pile wall and lagging wall in front of existing wall.

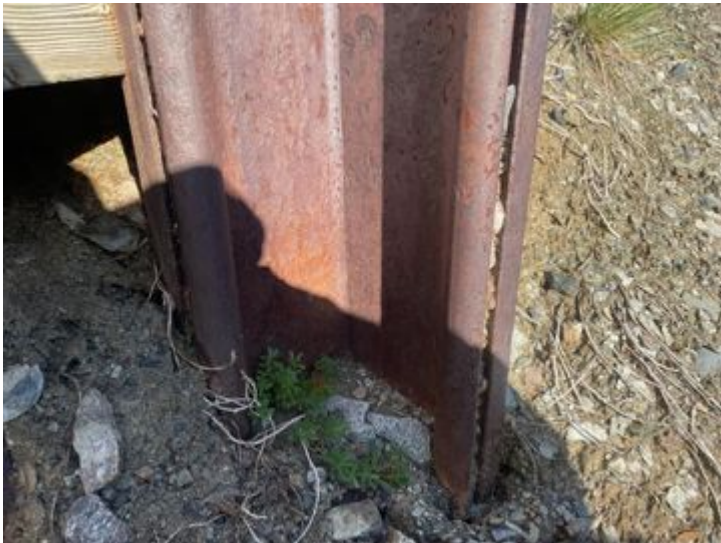
Comments:	Minor corrosion no measurable section loss	Date:	7/29/2021	Comments:	Typical	Date:	7/29/2021
		photo:	11			Photo:	12
Wall # 25 Wall Condition Rating: Poor		MP #:	354.26	Wall # 25 Wall Condition Rating: Poor		MP #:	354.26

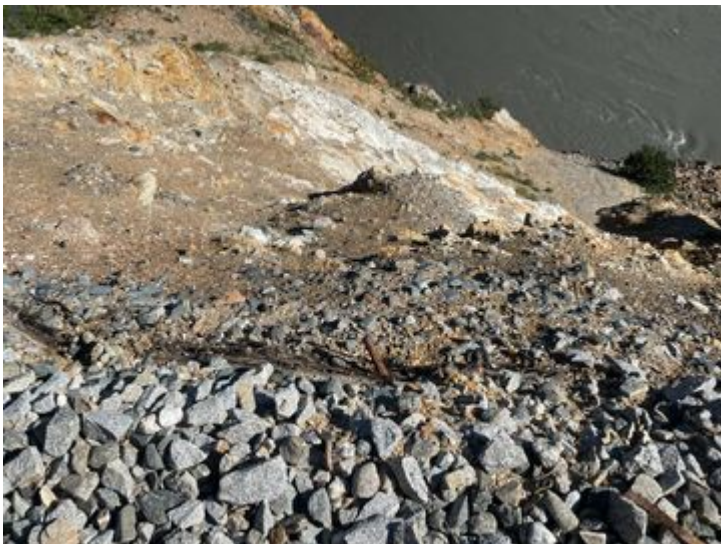
Comments:	Lateral timber member with 50% section loss	Date:	7/29/2021				
		photo:	9				
Wall # 36 Wall Condition Rating: Poor		MP #:	354.94

Wall 36 is critically damaged or in need of immediate repair, well past useful life. The consequences associated are the proximity of the wall to track. Lateral timber members exhibit section loss, which could result in failure.

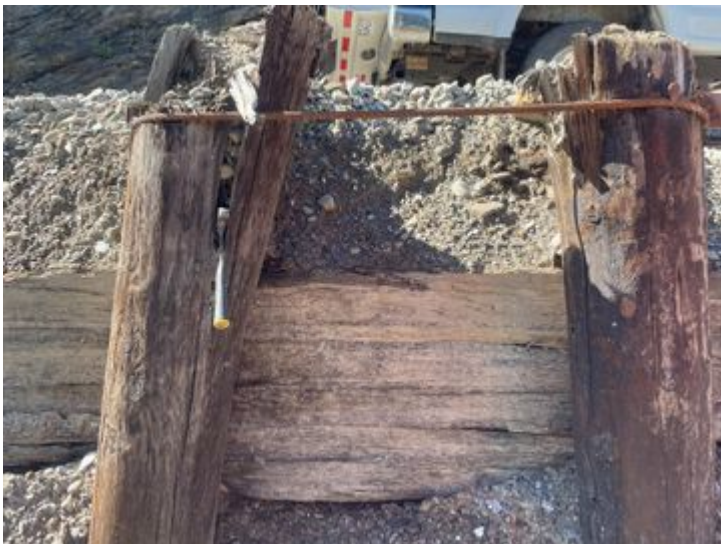
Comments:	Hollow sounding for entire height of exposed pile with splitting and decay	Date:	7/29/2021	Comments:	Lateral member decay	Date:	7/29/2021
		photo:	9			Photo:	10
Wall # 41 Wall Condition Rating: Poor		MP #:	355.41	Wall # 41 Wall Condition Rating: Poor		MP #:	355.41

Area surrounding the wall appears to be sliding with indications of loose/failing tiebacks causing the wall to rotate. The track is in close proximity to the wall, and could be in jeopardy if the slope failure continues.

- Piles-Exposed timber piles exhibit up to 100% section failure and are in need replacement.
- Lagging-Above grade segments are missing or exhibit up to 100% section failure and need replacement. Unable to inspect below grade segments due to apparent excavated fill from the opposite side of the track placed on the exterior toe of the wall. Further investigation is required to determine if below grade lagging is structurally sound and adequately retaining the fill supporting the track.
- Tiebacks-Unable to inspect tieback anchors. Further investigation is required to determine if steel cable tiebacks are to remain, but the current state of the wall indicates that these cables are not functioning as designed and could be the cause of the wall rotation.

Replace with soldier pile wall and lagging wall or steel sheet pile wall in front of the existing wall. May need tiebacks.

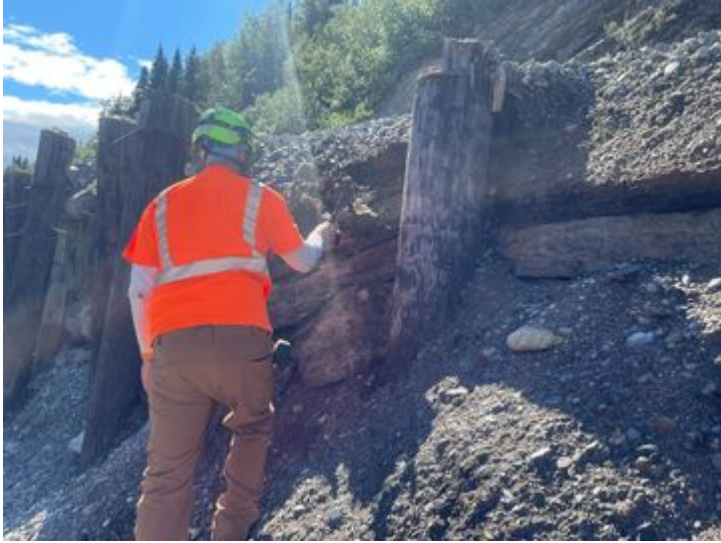
Comments:	Up to hundred percent of section loss top horizontal member	Date:	7/29/2021
		photo:	11
Wall # 41	Wall Condition Rating: Poor	MP #:	355.41

Wall 41 is critically damaged or in need of immediate repair, well past useful life. This is due to overall wall condition and the consequences associated with wall proximity to track and wall failure.

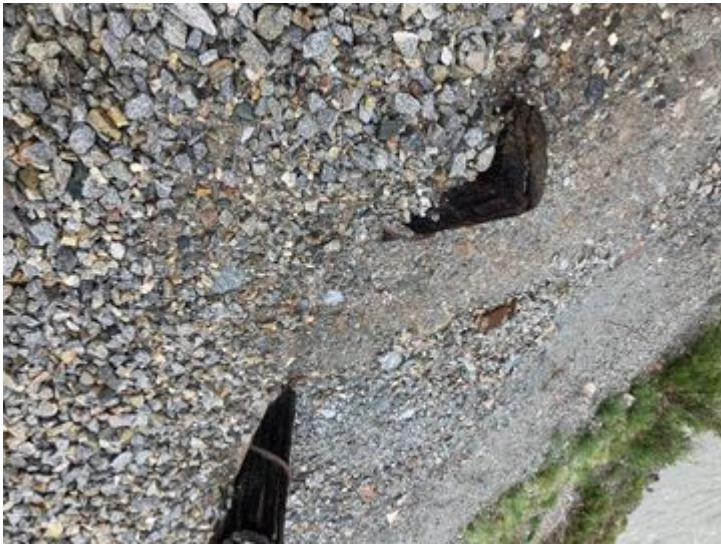
Comments:	Rotated longitudinally	Date:	7/28/2021
		photo:	9

Wall 17 is critically damaged or in need of immediate repair, well past useful life. Timber piles are failing, lagging is decaying, wall is rotating /sliding, and ballast is spilling over the top of the wall.

- Piles-Exposed timber piles sections exhibit section loss and are in need of replacement.
- Lagging-At-grade segments exhibit section failure and are in need replacement. Unable to inspect below grade segments due to ballast overflow on the exterior toe of the wall.
- Tiebacks-Timber tiebacks appear to be failing and might be the cause of the wall rotating. They will need to be replaced.

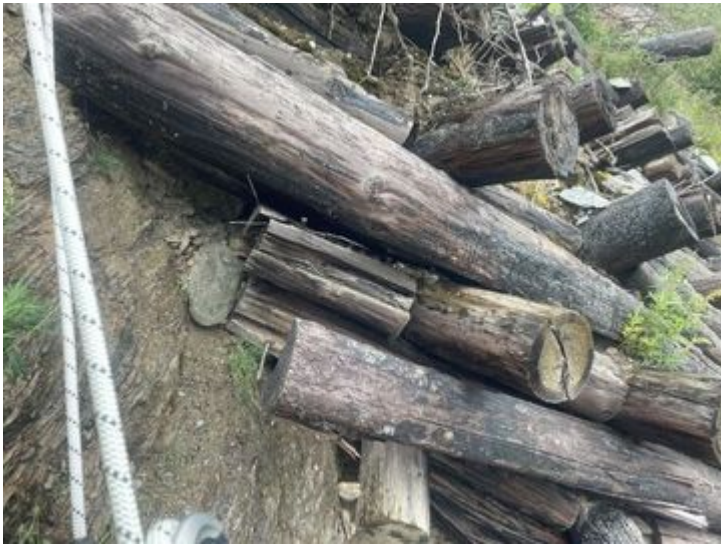
Comments:	Failure of lateral cribbing members typical	Date:	7/28/2021	Comments:	Failure of lateral cribbing members typical	Date:	7/28/2021
		photo:	7			Photo:	8
Wall # 22 Wall Condition Rating: Poor		MP #:	354.1	Wall # 22 Wall Condition Rating: Poor		MP #:	354.1

Wall 22 is critically damaged or in need of immediate repair, well past useful life. The wall is losing fill, and members are dislodged, which may be the cause of the sliding and rotating in the wall.

- Headers- Exhibit crushing and are dislodged which appears to be the cause of the crib wall not retaining soil.
- Stretchers-Are dislodged and are likely the cause of the wall sliding.

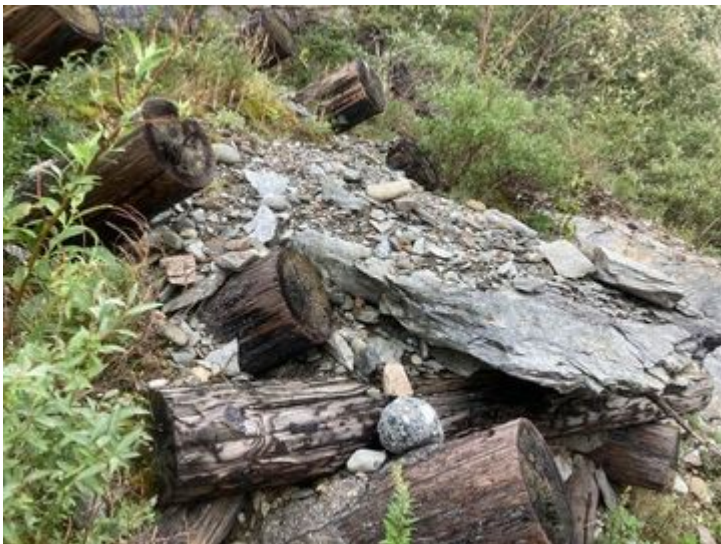
Comments:	Dislodged members with rock ball	Date:	7/28/2021	Comments:	Under cutting slope failure while shifting down	Date:	7/28/2021
		photo:	9			Photo:	10
Wall # 22 Wall Condition Rating: Poor		MP #:	354.1	Wall # 22 Wall Condition Rating: Poor		MP #:	354.1

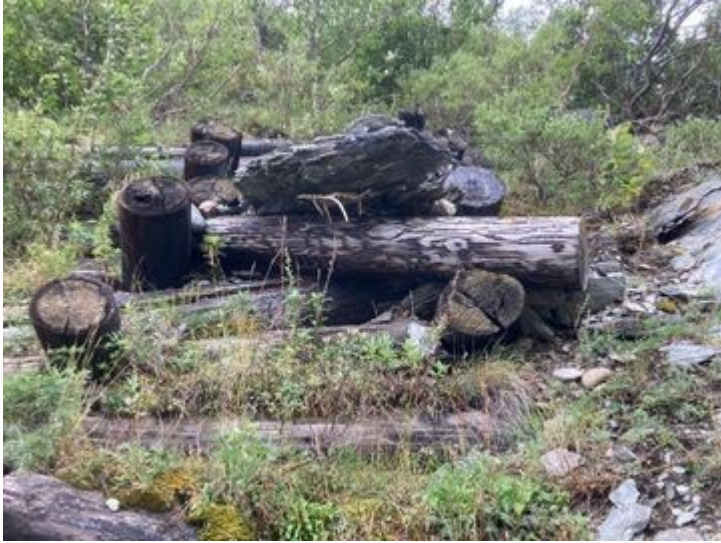
Comments:	Dislodged members with rockfall	Date:	7/28/2021	Comments:	Typical elevation	Date:	7/28/2021
		photo:	11			Photo:	12
Wall # 22 Wall Condition Rating: Poor		MP #:	354.1	Wall # 22 Wall Condition Rating: Poor		MP #:	354.1
Comments:		Date:	7/28/2021	Comments:		Date:	7/28/2021
		photo:	13			Photo:	14
Wall # 22 Wall Condition Rating: Poor		MP #:	354.1	Wall # 22 Wall Condition Rating: Poor		MP #:	354.1

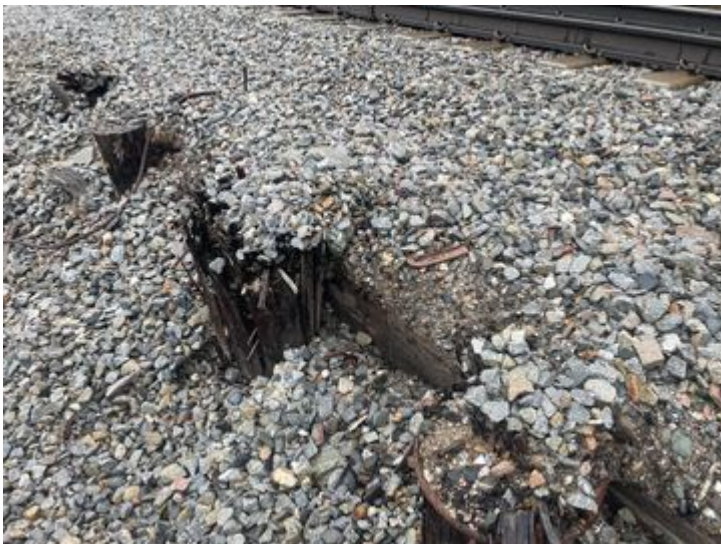
Comments:	25%-50% section loss/decay/rot	Date:	7/28/2021	Comments:	Up to 100% section loss/decay/rot	Date:	7/28/2021
		photo:	9			Photo:	10
Wall # 4 Wall Condition Rating: Poor		MP #:	351.2	Wall # 4 Wall Condition Rating: Poor		MP #:	351.2
