**ALASKA RAILROAD CORPORATION**  
327 W. Ship Creek Ave.  
Anchorage, AK 99501.

Seward Freight Dock: Damage Repairs and Upgrades

# **SWD FREIGHT DOCK: REPAIRS AND IMPROVEMENTS**

## **REQUEST FOR QUOTE SET**

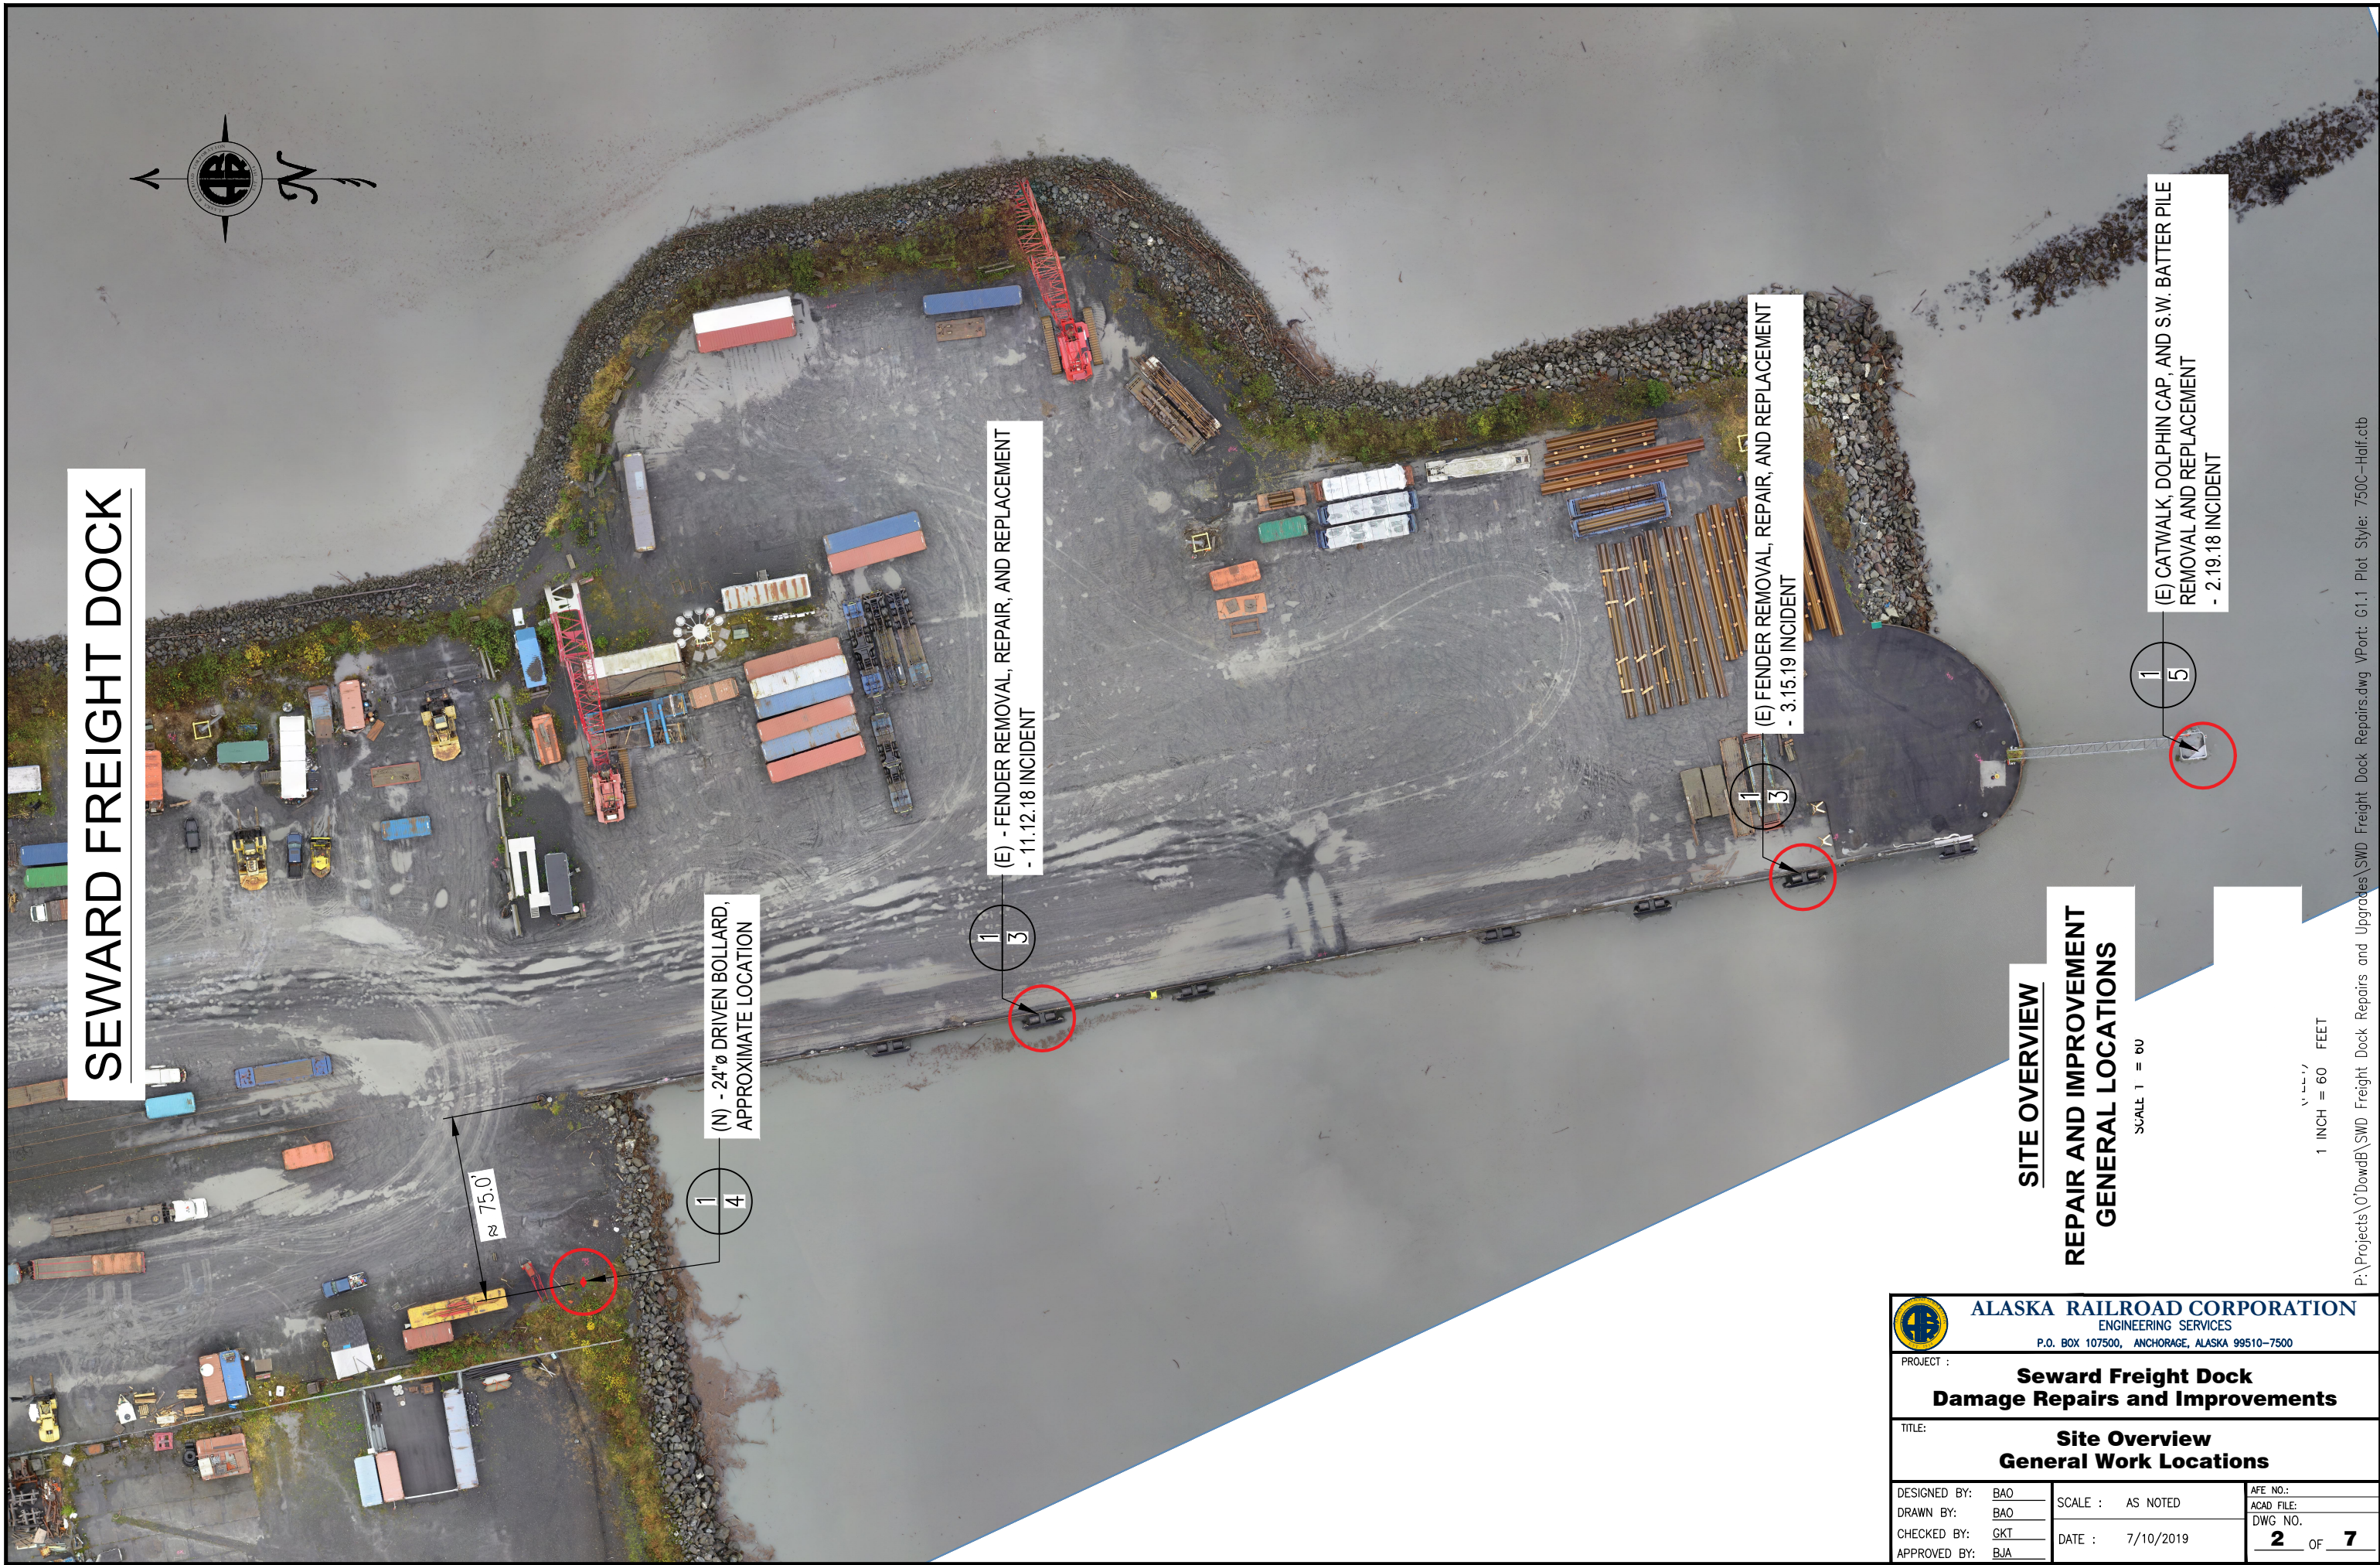
## SITE OVERVIEW REPAIR AND IMPROVEMENT GENERAL LOCATIONS

(N) - 24"Ø DRIVEN BOLLARD,  
APPROXIMATE LOCATION

(E) - FENDER REMOVAL, REPAIR, AND REPLACEMENT  
- 11.12.18 INCIDENT

(E) FENDER REMOVAL, REPAIR, AND REPLACEMENT  
- 3.15.19 INCIDENT

(E) CATWALK, DOLPHIN CAP, AND S.W. BATTER PILE  
REMOVAL AND REPLACEMENT  
- 2.19.18 INCIDENT

<b>ALASKA RAILROAD CORPORATION</b> ENGINEERING SERVICES P.O. BOX 107500, ANCHORAGE, ALASKA 99510-7500		
PROJECT :		
<b>Seward Freight Dock Damage Repairs and Improvements</b>		
TITLE:		
<b>Site Overview General Work Locations</b>		
DESIGNED BY: BAO	SCALE : AS NOTED	AFE NO.:
DRAWN BY: BAO	DATE : 7/10/2019	ACAD FILE:
CHECKED BY: GKT		DWG NO.
APPROVED BY: BJA		<b>2</b> OF <b>7</b>

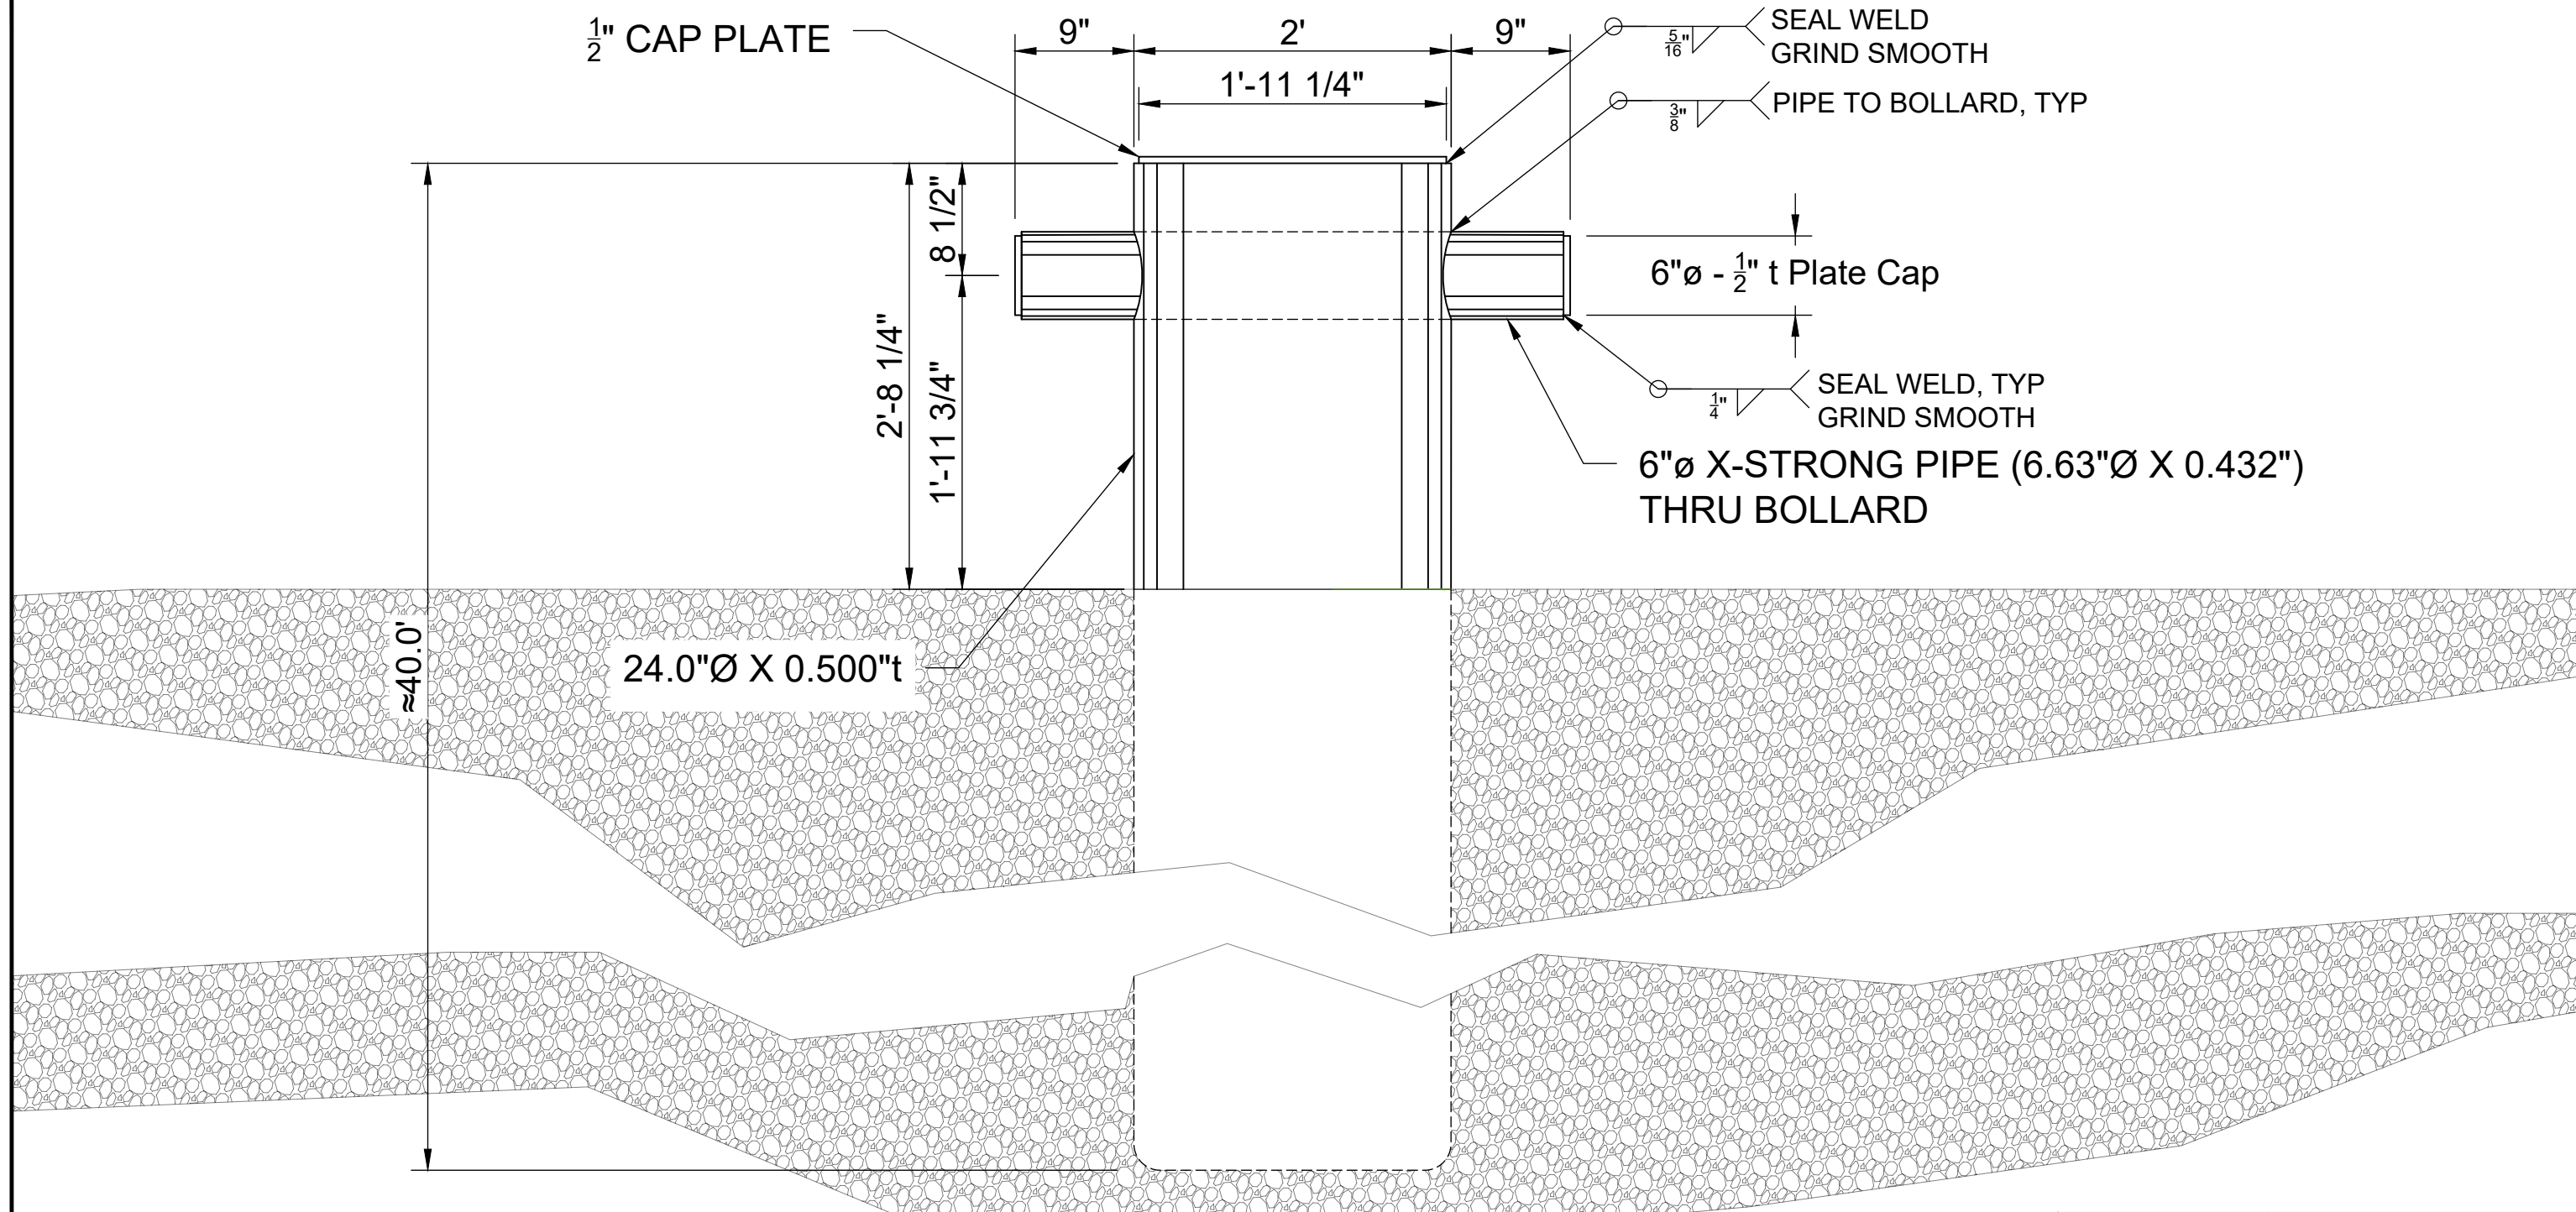
# 24"Ø DRIVEN BOLLARD

<b>ALASKA RAILROAD CORPORATION</b> ENGINEERING SERVICES P.O. BOX 107500, ANCHORAGE, ALASKA 99510-7500		
PROJECT : <b>Seward Freight Dock Damage Repairs and Improvements</b>		
TITLE: <b>24"Ø Driven Bollard Elevation View</b>		
DESIGNED BY: BAO	SCALE : AS NOTED	AFE NO.:
DRAWN BY: BAO	DATE : 7/10/19	ACAD FILE:
CHECKED BY: GKT		DWG NO. <b>4</b> OF <b>7</b>
APPROVED BY: BJA

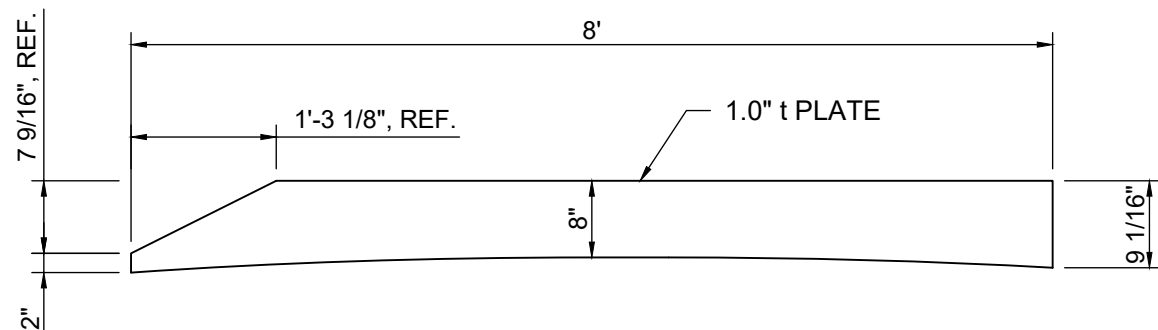
## PLAN VIEW - INDIVIDUAL TORSION PLATE

TITLE:  
**Torsion Plate Assembly and Details  
for 24"ø x 0.500"t Pipe Pile**

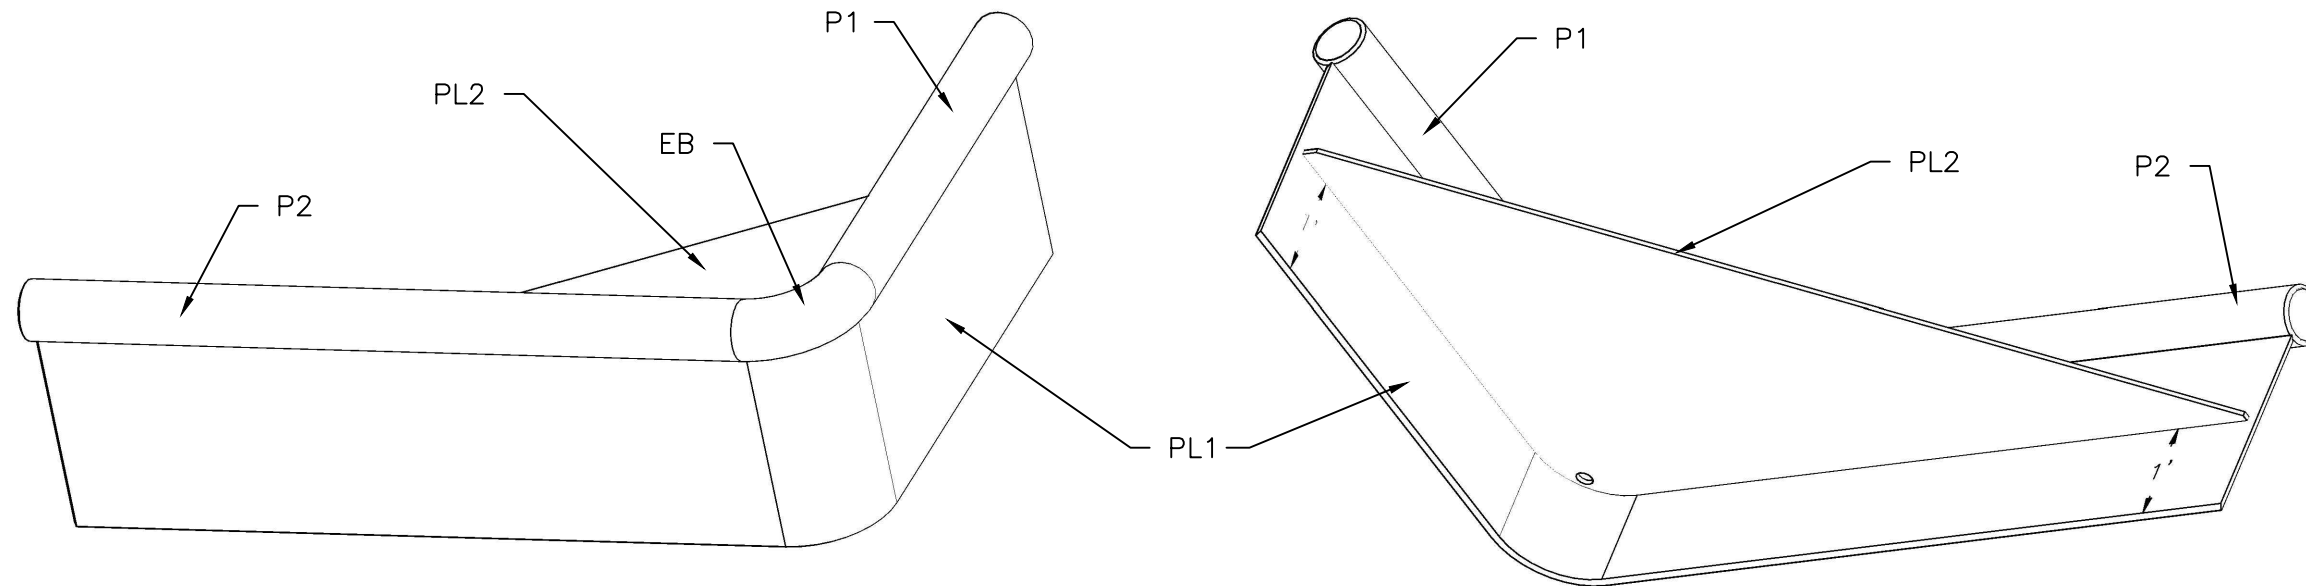
3D View from outside & above

3D View from inside & below

1. Repair any breaks in zinc coating with two coats of cold spray galvanizing.
2. All welding shall be done in accordance with AWS D1.1.
3. Perform weld procedure to minimize distortion of plates. Distortion tolerances:
  - 3.1. PL2 shall not have more than 1/2" out of plane distortion everywhere except the plate free edge where it shall have no more than 1/4" distortion.
  - 3.2. PL1 free edges shall not deviate from shown not more than 3/16".
  - 3.3. Should final assembly not conform to the above criteria, utilize thermal and/or mechanical straightening techniques as required to meet the criteria.

<b>ALASKA RAILROAD CORPORATION</b> ENGINEERING SERVICES P.O. BOX 107500, ANCHORAGE, ALASKA 99510-7500		
PROJECT :		
<b>Seward Freight Dock Damage Repairs and Improvements</b>		
TITLE:		
<b>2011 Incident - Fabrication Drawing Complete Assembly 3D Views</b>		
DESIGNED BY: DCO	SCALE : AS NOTED	AFE NO.:
DRAWN BY: DCO		ACAD FILE:
CHECKED BY: _____	DATE : Oct 11, 2011	DWG NO.
APPROVED BY: _____		<b>6</b> OF <b>7</b>

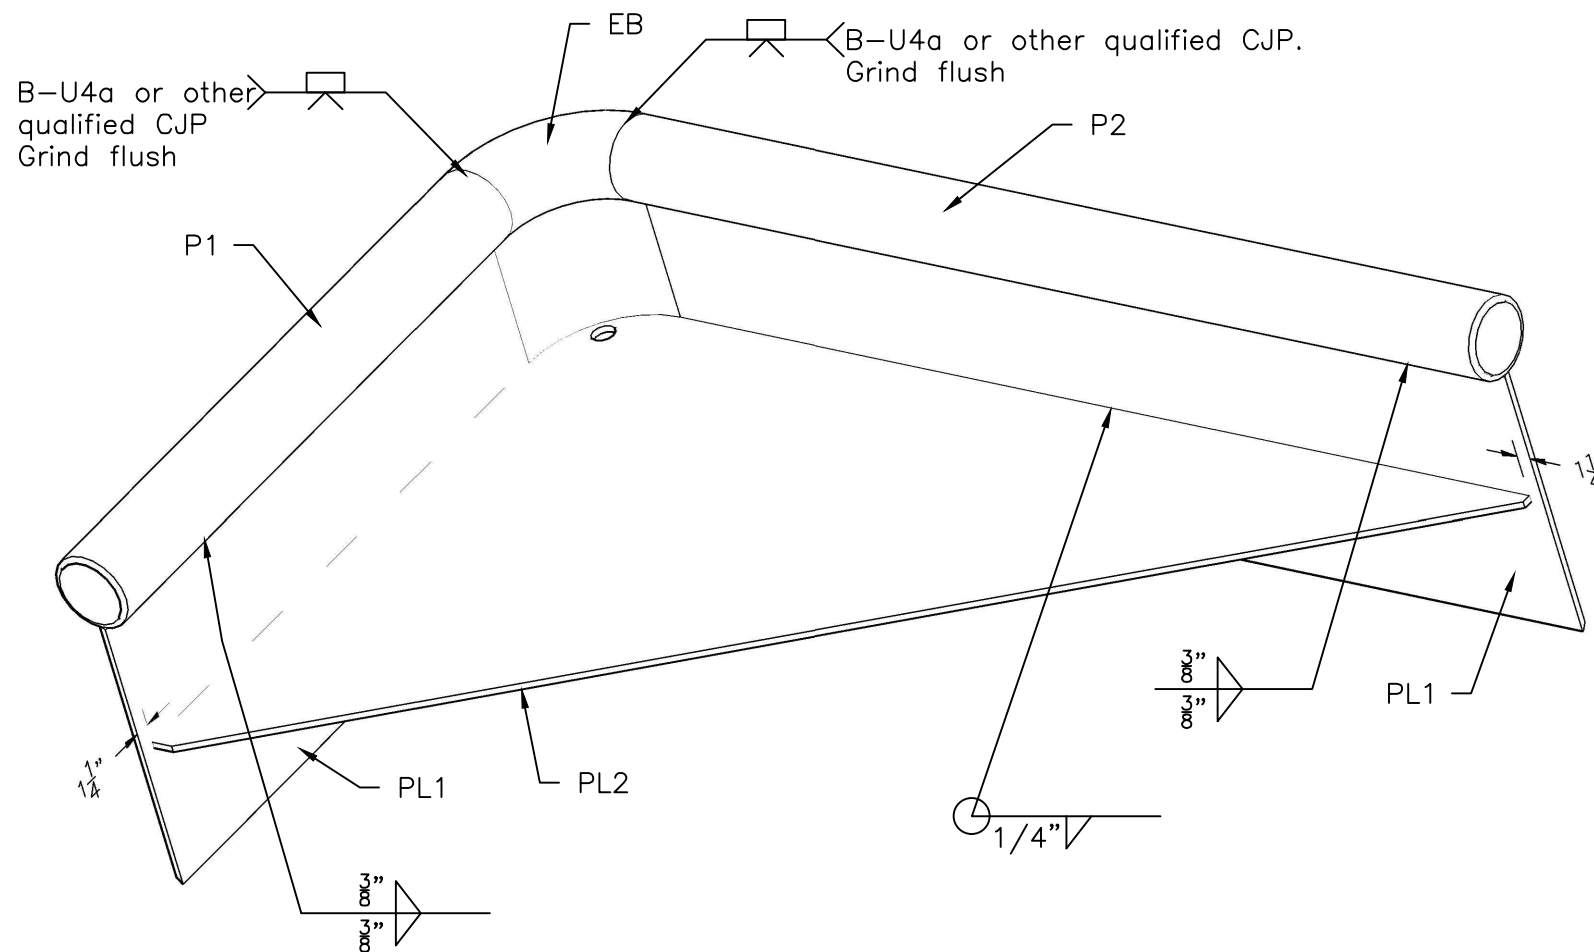
3D View from inside & above

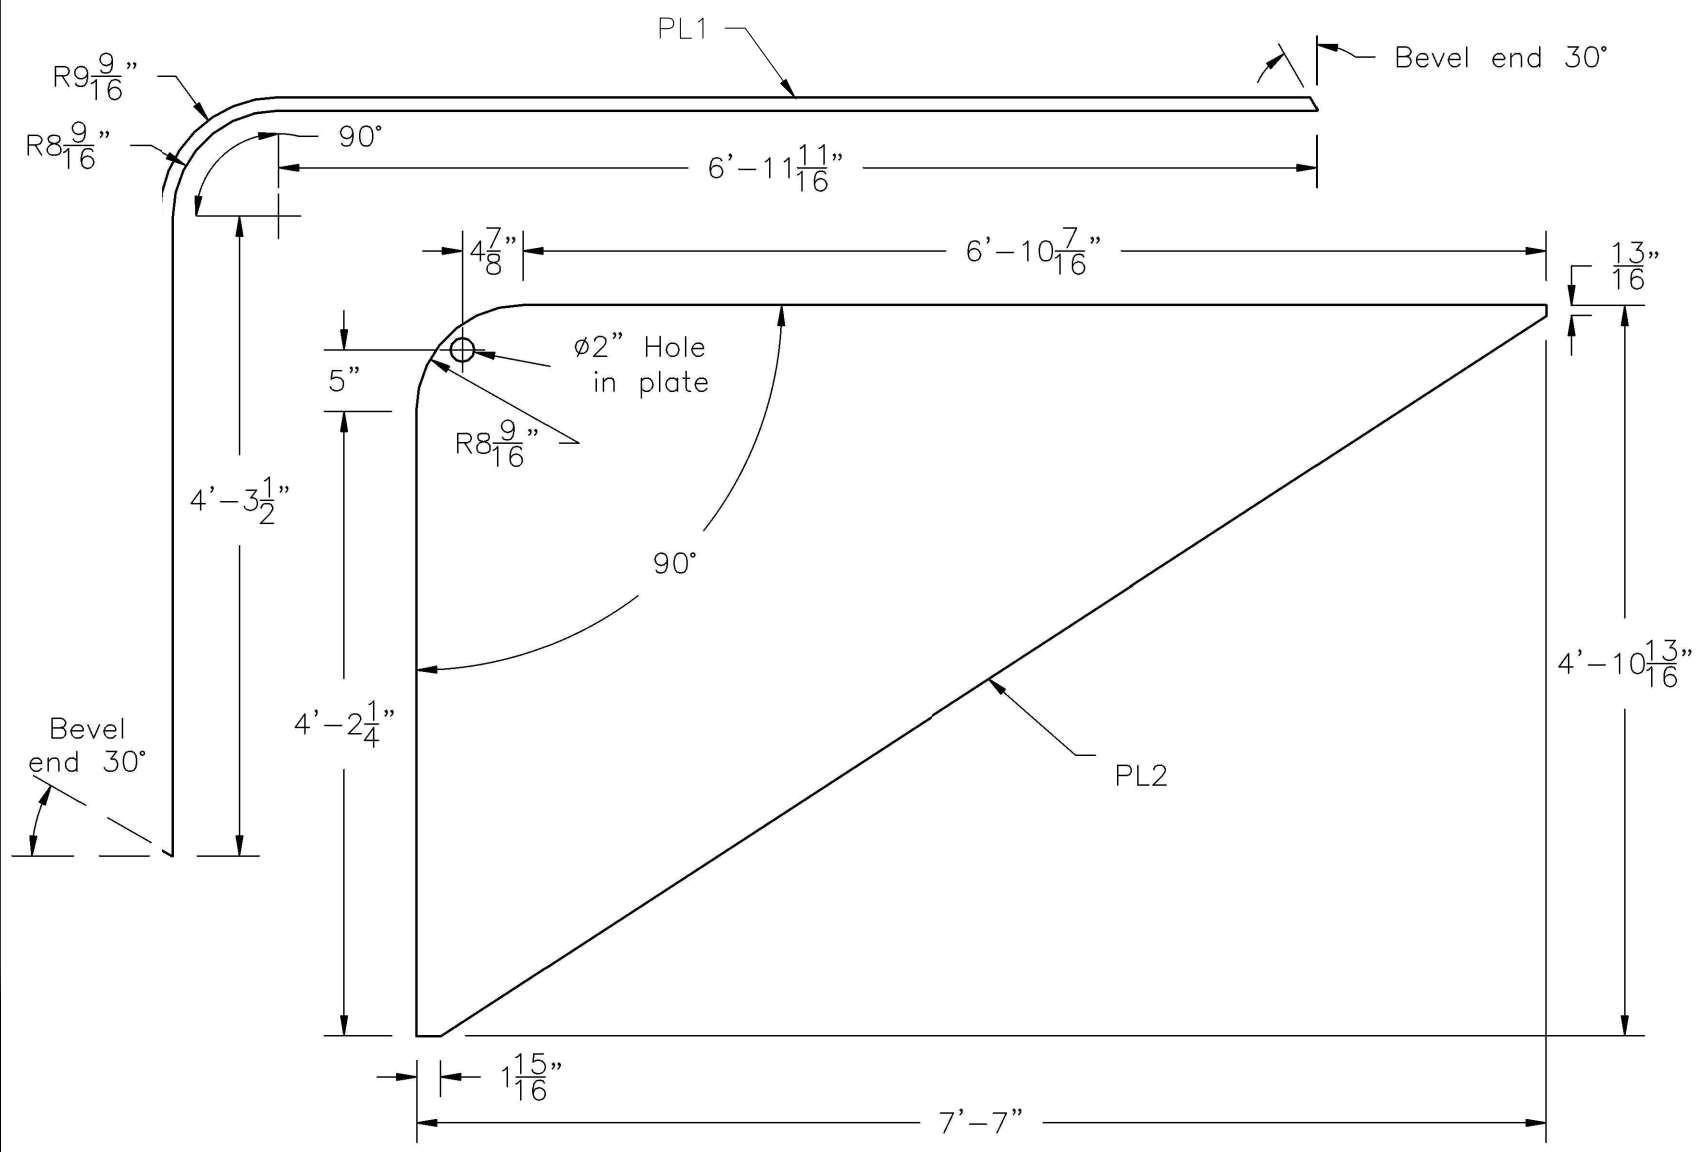
Seward East Dock Dolphin Repair			Length		Qty	Total Weight #	See Dwg	Note
Item	Material	Mark	Ft	In				
6" dia sch 80 pipe	A53 Gr B	P1	4	3.5	1	123	---	Prepare both ends for butt weld connection**
6" dia sch 80 pipe	A53 Gr B	P2	6	11.5	1	199	---	Prepare both ends for butt weld connection**
6" dia sch 80 pipe long radius butt weld elbow	A53 Gr B	EB	---	---	1	35	---	Prepare both ends for butt weld connection
Backing ring for 6" sch 80 pipe	A109	BR	---	---	5*		---	Ship 3 loose
Plate, 1" thick x 2'-0" wide	A36	PL1	12	5	1	1016	2	Bend as shown
Plate, 1/2" thick x 4'-10-13/16" wide	A36	PL2	7	7	1	509	2	Roughly triangular
Flat bar, 3/8" thick x 2" wide	A36	FB1	2	0	3	15	---	Ship loose
Total weight:						1897

\*Backing ring quantity will be 3 if backing rings not used to weld EB to P1&P2  
 \*\*Bevels for non-shop weld ends shall be 30 degrees single bevel.  
 Note: all material shall be hot dipped galvanized or outside surfaces thermal spray metallized

Notes:  
 1. Hole in PL2 may be plasma cut.

<b>ALASKA RAILROAD CORPORATION</b> ENGINEERING SERVICES P.O. BOX 107500, ANCHORAGE, ALASKA 99510-7500		
PROJECT : <b>Seward Freight Dock Damage Repairs and Improvements</b>		
TITLE: <b>2011 Incident - Shop Drawing</b>		
DESIGNED BY: DCO	SCALE : AS NOTED	AFE NO.:
DRAWN BY: DCO	DATE : Oct 11, 2011	ACAD FILE:
CHECKED BY:		DWG NO. <b>7</b> OF <b>7</b>
APPROVED BY:
