**Table 1-2 Evaluation and Assessment Summary**

Alaska Railroad Corporation hired PND Engineers, Inc. to provide the condition assessment services on the Whittier Marine Terminal. PND's Michael Beglin provided an initial site visit on September 29<sup>th</sup>, 2020 to review the project site and meet with ARRC's Elizabeth Greer.

The inspection was conducted as a Routine Inspection as outlined in the *ASCE Manuals and Reports on Engineering Practice No. 130 (MOP 130)*, **Waterfront Facilities Inspection and Assessment**. The purpose of the inspection was to assess the general condition of the structures, assign a condition assessment rating to each structure, assign element-level damage ratings to each structural component, provide maintenance recommendations, and advise client on maintenance priorities.

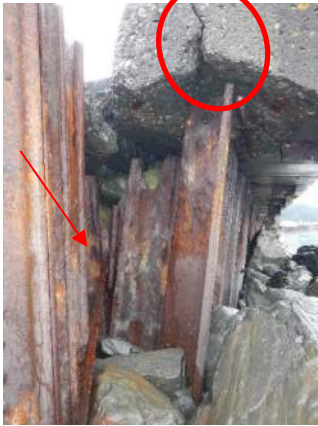
| A photograph showing a sheet pile wall. A red circle highlights a crack in the concrete at the top. A red arrow points to a split sheet pile knuckle. | <p>Photograph No. MW-1</p> <p><u>Description:</u></p> <p>Sheet pile wall is leaning seaward along the eastern end, approx. 50-feet in length. A split sheet pile knuckle was observed at the NE corner. The split knuckle occurs at a tailwall and/or terminal end wall. Photo looking west. Additionally, the concrete is spalled and cracked along the sheet pile to cap interface.</p> |

- PND recommends the following action items: Immediately restrict heavy loads from the NE corner, where the wall is leaning.
- Within the next 1-3 years, install a new catwalk support (turning dolphin #4). Restrict use of the catwalk until a competent support is installed.
- At an appropriate low tide, inspect the face of the wall for localized failures in the sheet pile and patch as necessary. Fill sinkholes due to scour and patch holes as they form, until full replacement can be accomplished.
- Repair damaged appurtenances as soon as practical.
- Due to the widespread section loss and deficiencies observed, a full replacement of the Marginal Wharf sheet pile wall should take place within the next 3-6 years. In order to do this, the design and permit process should begin within the next 1-3 years.
- Continue routine inspection of the structure, at a minimum of every 2 years.

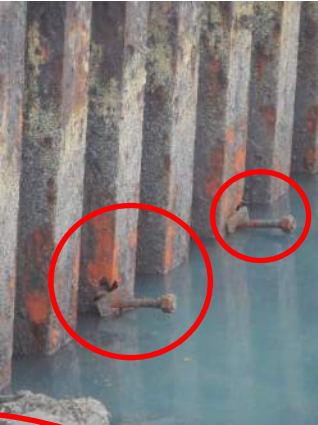
| A photograph showing sheet piles with two red circles highlighting holes near tie back rods. | <p>Photograph No. MW-2</p> <p><u>Description:</u></p> <p>Observed holes in the sheet piles at (2) locations near tie back rods, at the eastern end of the dock.</p> |

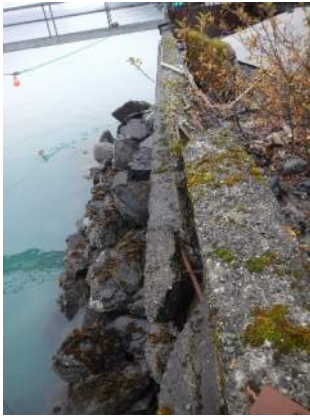
Photograph No. MW-4

Concrete spalling and cracking was observed in places along the concrete sheet pile cap. Rebar is exposed in several locations and cracks exceed 1/4" near the east end, as well as, along the sheet pile to cap interface.

The damaged concrete cap and sheet pile at the east end of the wharf, compromises the support provided to the catwalk for dolphin #4 access.

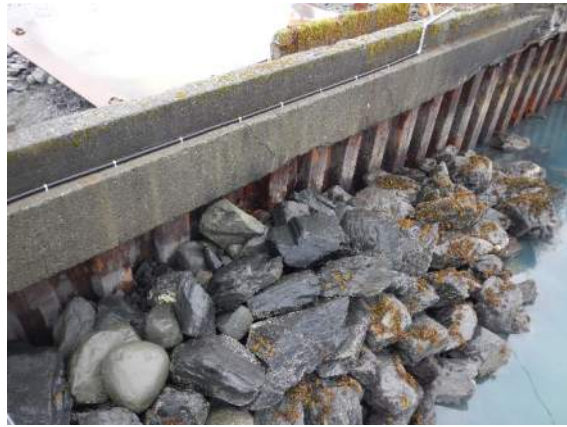
Photograph No. MW-7

Armor rock and riprap used for slope stability appears stable and/or well maintained. The original slope and elevation of slope protection rock is unknown.

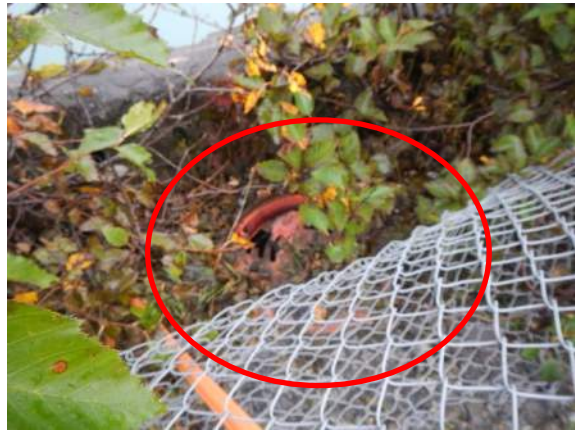
Photograph No. MW-8

Damaged manhole cover observed.

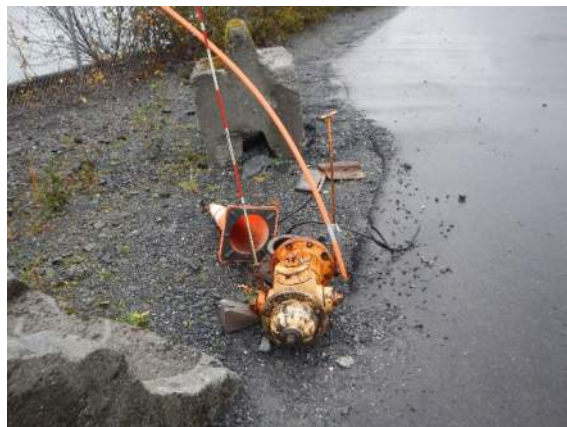
Photograph No. MW-9

Damaged fire hydrant observed.

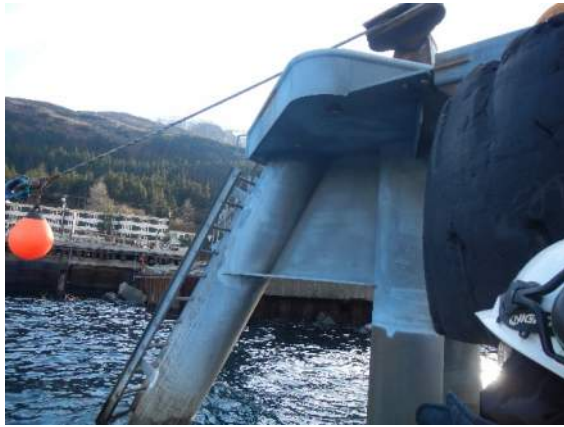
Photograph No. D4-1

Minor coating damage and corrosion observed.

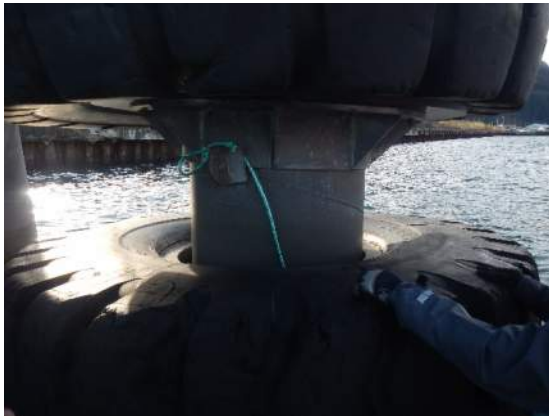
Photograph No. D4-4

Minor deterioration to tire fenders, such as, cuts, gouges, tears, etc.

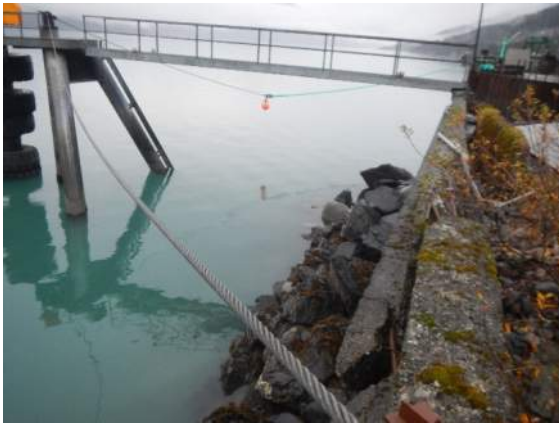
Photograph No. D4-5

Minor coating damage and corrosion observed.

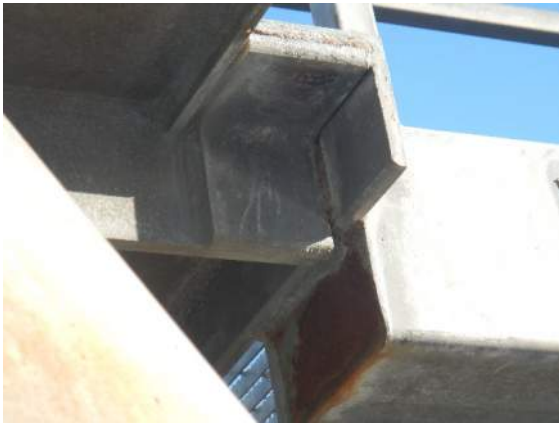
Photograph No. D4-6

Catwalk to dolphin cap connection.

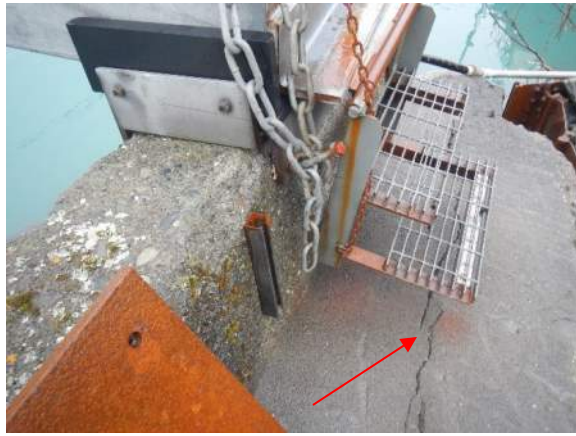
Photograph No. D4-7

Catwalk to Marginal Wharf cap connection. Note cracking of concrete cap.

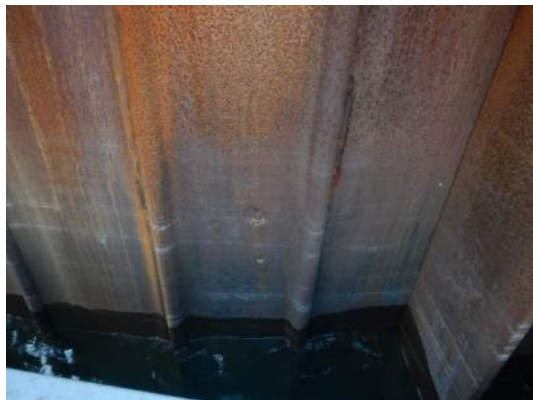
Photograph No. TR-5

All sheet piles are affected by corrosion with visible reduction of wall thickness at pitting locations.

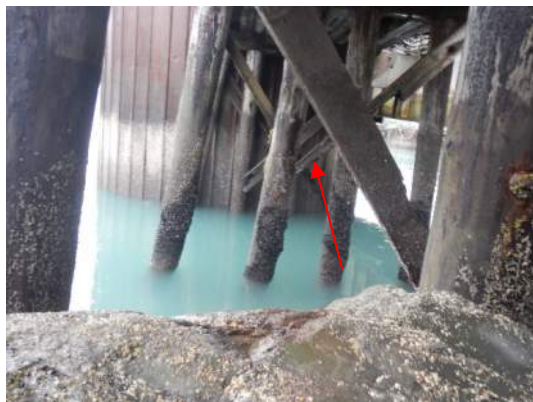
Photograph No. TR-6

All diagonal timber braces on the pile bents (for lateral support) are severely damaged

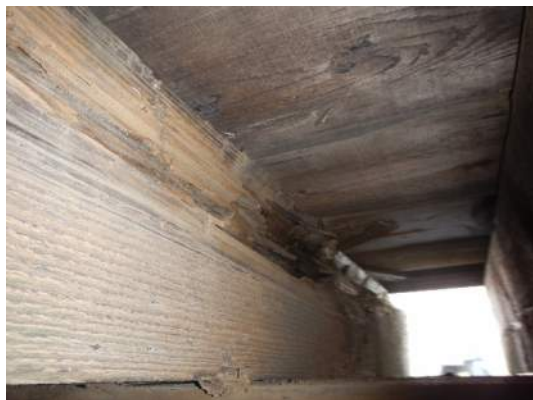
Photograph No. TR-7

Crushing transverse deck timber near the abutment.

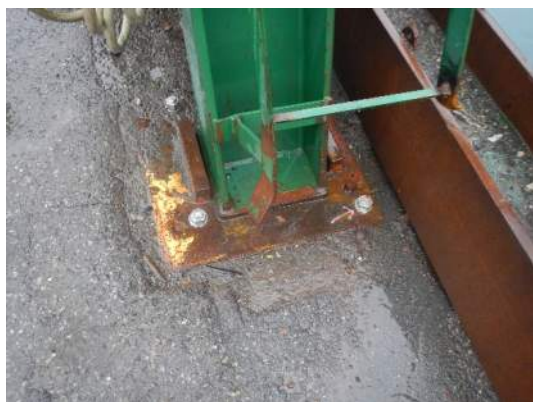
Photograph No. TB-1

(2) loose bolts were found at the support on the NW corner.

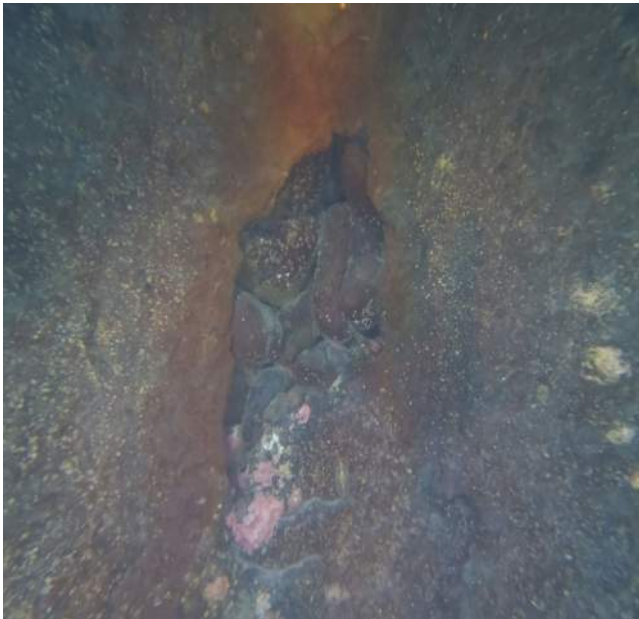
Image 6 - 10"x5" Hole, West Side Cell

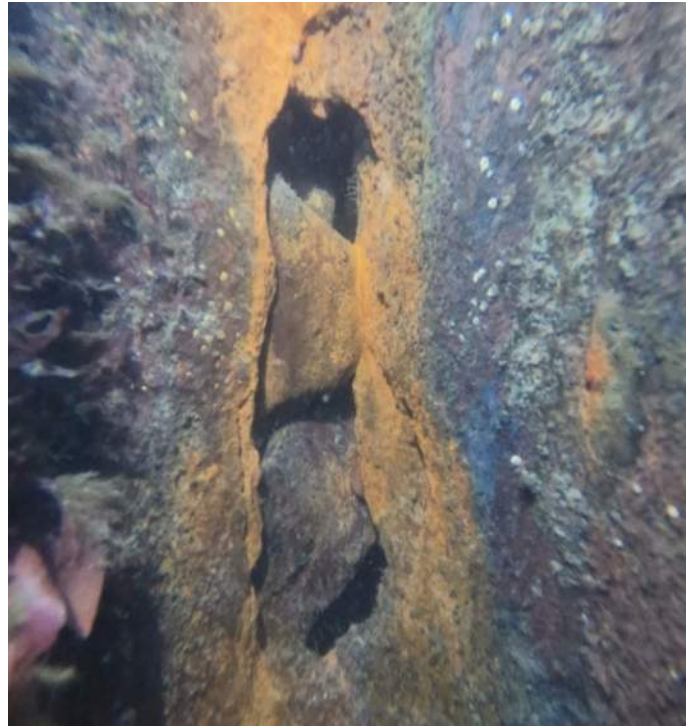
Image 19 – 4" x 11" Hole, South side cell

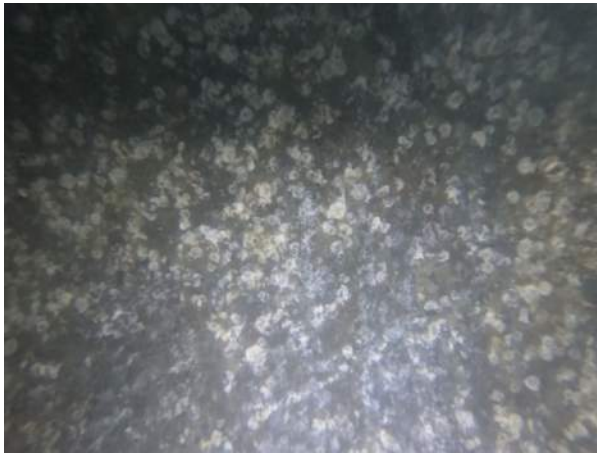
Image 21 – Typical Surface Condition

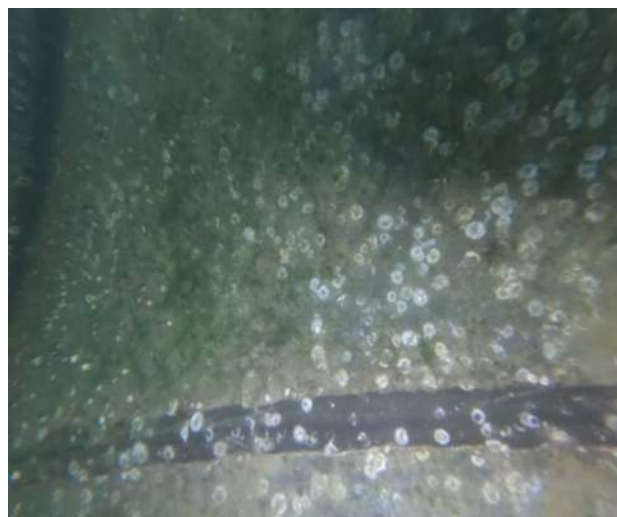
Image 25 – Trestle Steel Pile, Typical Condition

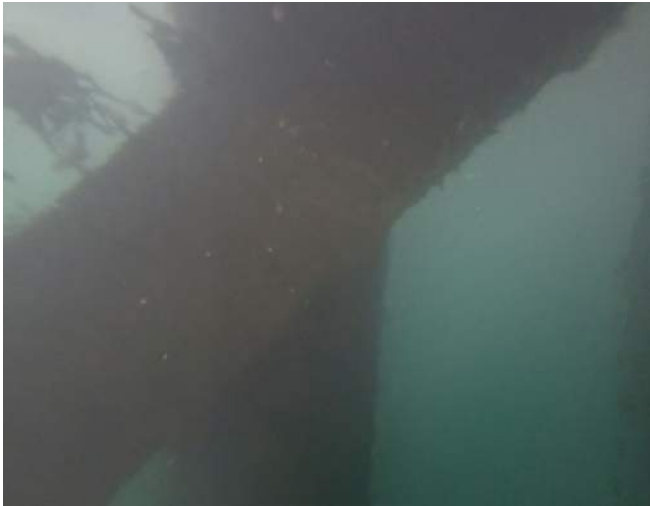
On trestle structures supported by timber pile, the survey found that the piles on the trestles appeared to be in good condition, soundings were found to be solid not punky or hollow. However up to 90% of the X-Beams cross members were not supporting all the vertical piles, the majority of them where deteriorated to the point of falling off the piles. Representative core samples were taken on each structure with timber piles. All sample locations received galvanized lag bolt plugs with rubber washer seals.

Image 26 – X-Member Beam Typical

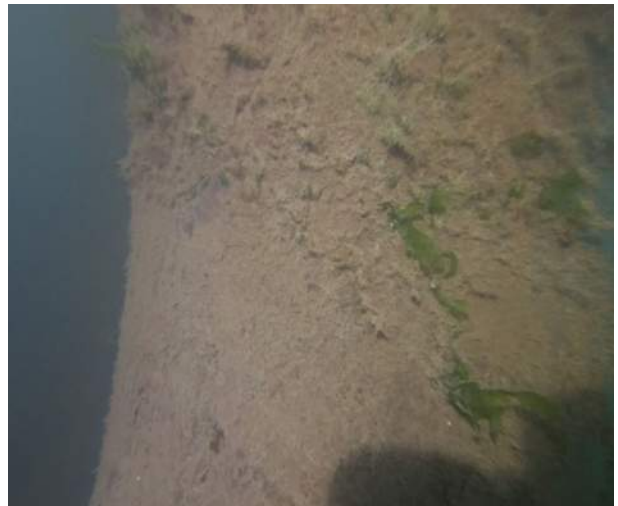
Image 27 – Typical Pile Light Growth

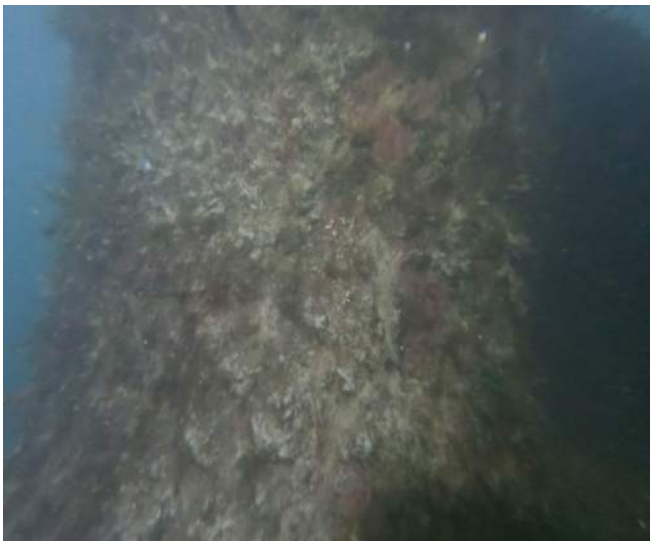
Image 28 – Typical Pile Growth near surface
